# Clayton Beach Restoration Feasibility and Alternative Analysis Design Report

## Skagit County, Washington

Prepared for  
Northwest Straits Conservation Foundation  
Prepared by  
Herrera Environmental Consultants, Inc.

May 2, 2024

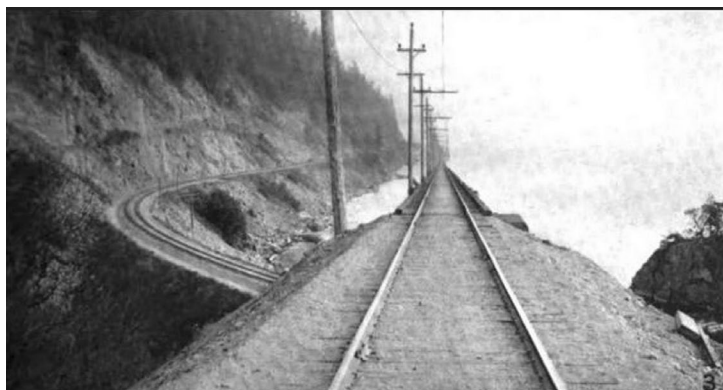
Photo 2. Circa 1912 – Looking southward at the completed trestle section of the B&SI Railway at Clayton Beach with the crossing of the GN Railway (left). Photo from Western Washington University, Heritage Resources.

The GN Railway was constructed in the late 1800's prior to the Bellingham and Skagit Interurban (B&SI) Railway which was constructed in approximately 1912. In the process of building the GN railway, a bench was blasted into the Chuckanut Formation bedrock to create a foundation for the railbed. Blasted debris and graded materials were side cast where they typically accumulated along the shoreline. Historic photographic information supports this hypothesis (Photos 1 and 2).

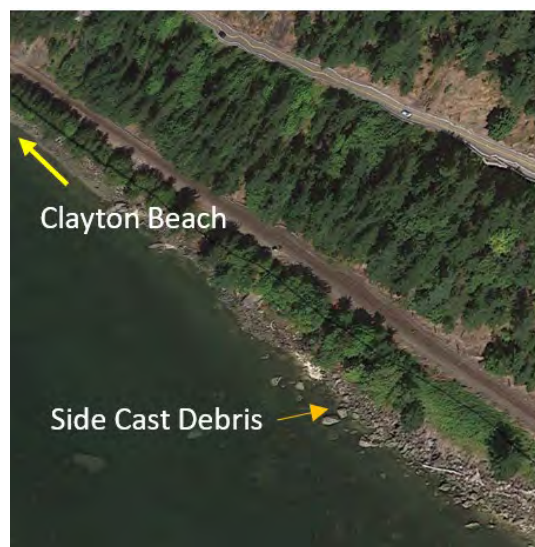
Photo 4. Residual armoring along the shoreline near Clayton Beach (2022).

Invariably, the blasted material was delivered to the shoreline environment where it created a coarse, “armor-like” fill that extended into the intertidal zone (Photo 3). The introduction of this fill material would have influenced wave and erosion processes along the shoreline by effectively armoring it with large boulders and changing the configuration of the natural, historical position of the shoreline. While the shoreline already represented a supply-limited transport condition because of the loss of sediment from the Skagit River, the effective armoring of the shoreline south of Clayton Beach area with large side cast would have further interrupted sediment supply delivered from the upland areas adjacent to the shoreline, thus compounding the upland sediment supply-limited conditions. This armored condition persists to this day (Photo 4).

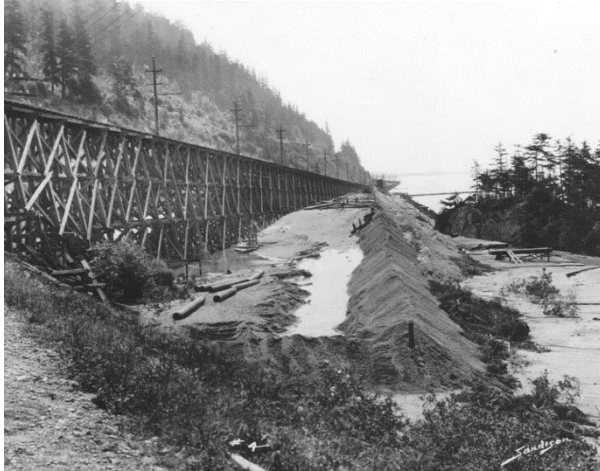
*Photo 5. Looking south at containment levee used to contain fill from the suction dredge. Photo from Western Washington University, Heritage Resources.*

As part of the B&SI Railway development, a program of suction dredging of the subtidal area adjacent to Clayton Beach was initiated to provide fill to construct a platform for a B&SI Railway station platform. This fill also potentially structurally improved the large wooden railway causeway but left a legacy of a 13-acre unvegetated deep hole offshore (Photos 5 and 6).

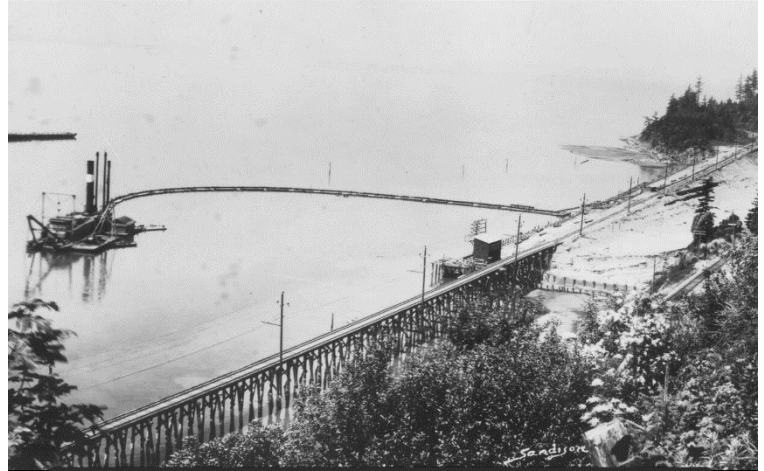
*Photo 6. Looking northerly at Clayton Beach area with suction dredge providing fill for platform construction. Photo from Western Washington University, Heritage Resources.*

Constructed in 1912, the trestle immediately became a problem for the overwater sections of the route. Service diminished following World War 1 when paved roads and the growing popularity of automobiles increased. Service ended in 1928 and the line was officially abandoned in 1930, but the fill remained.

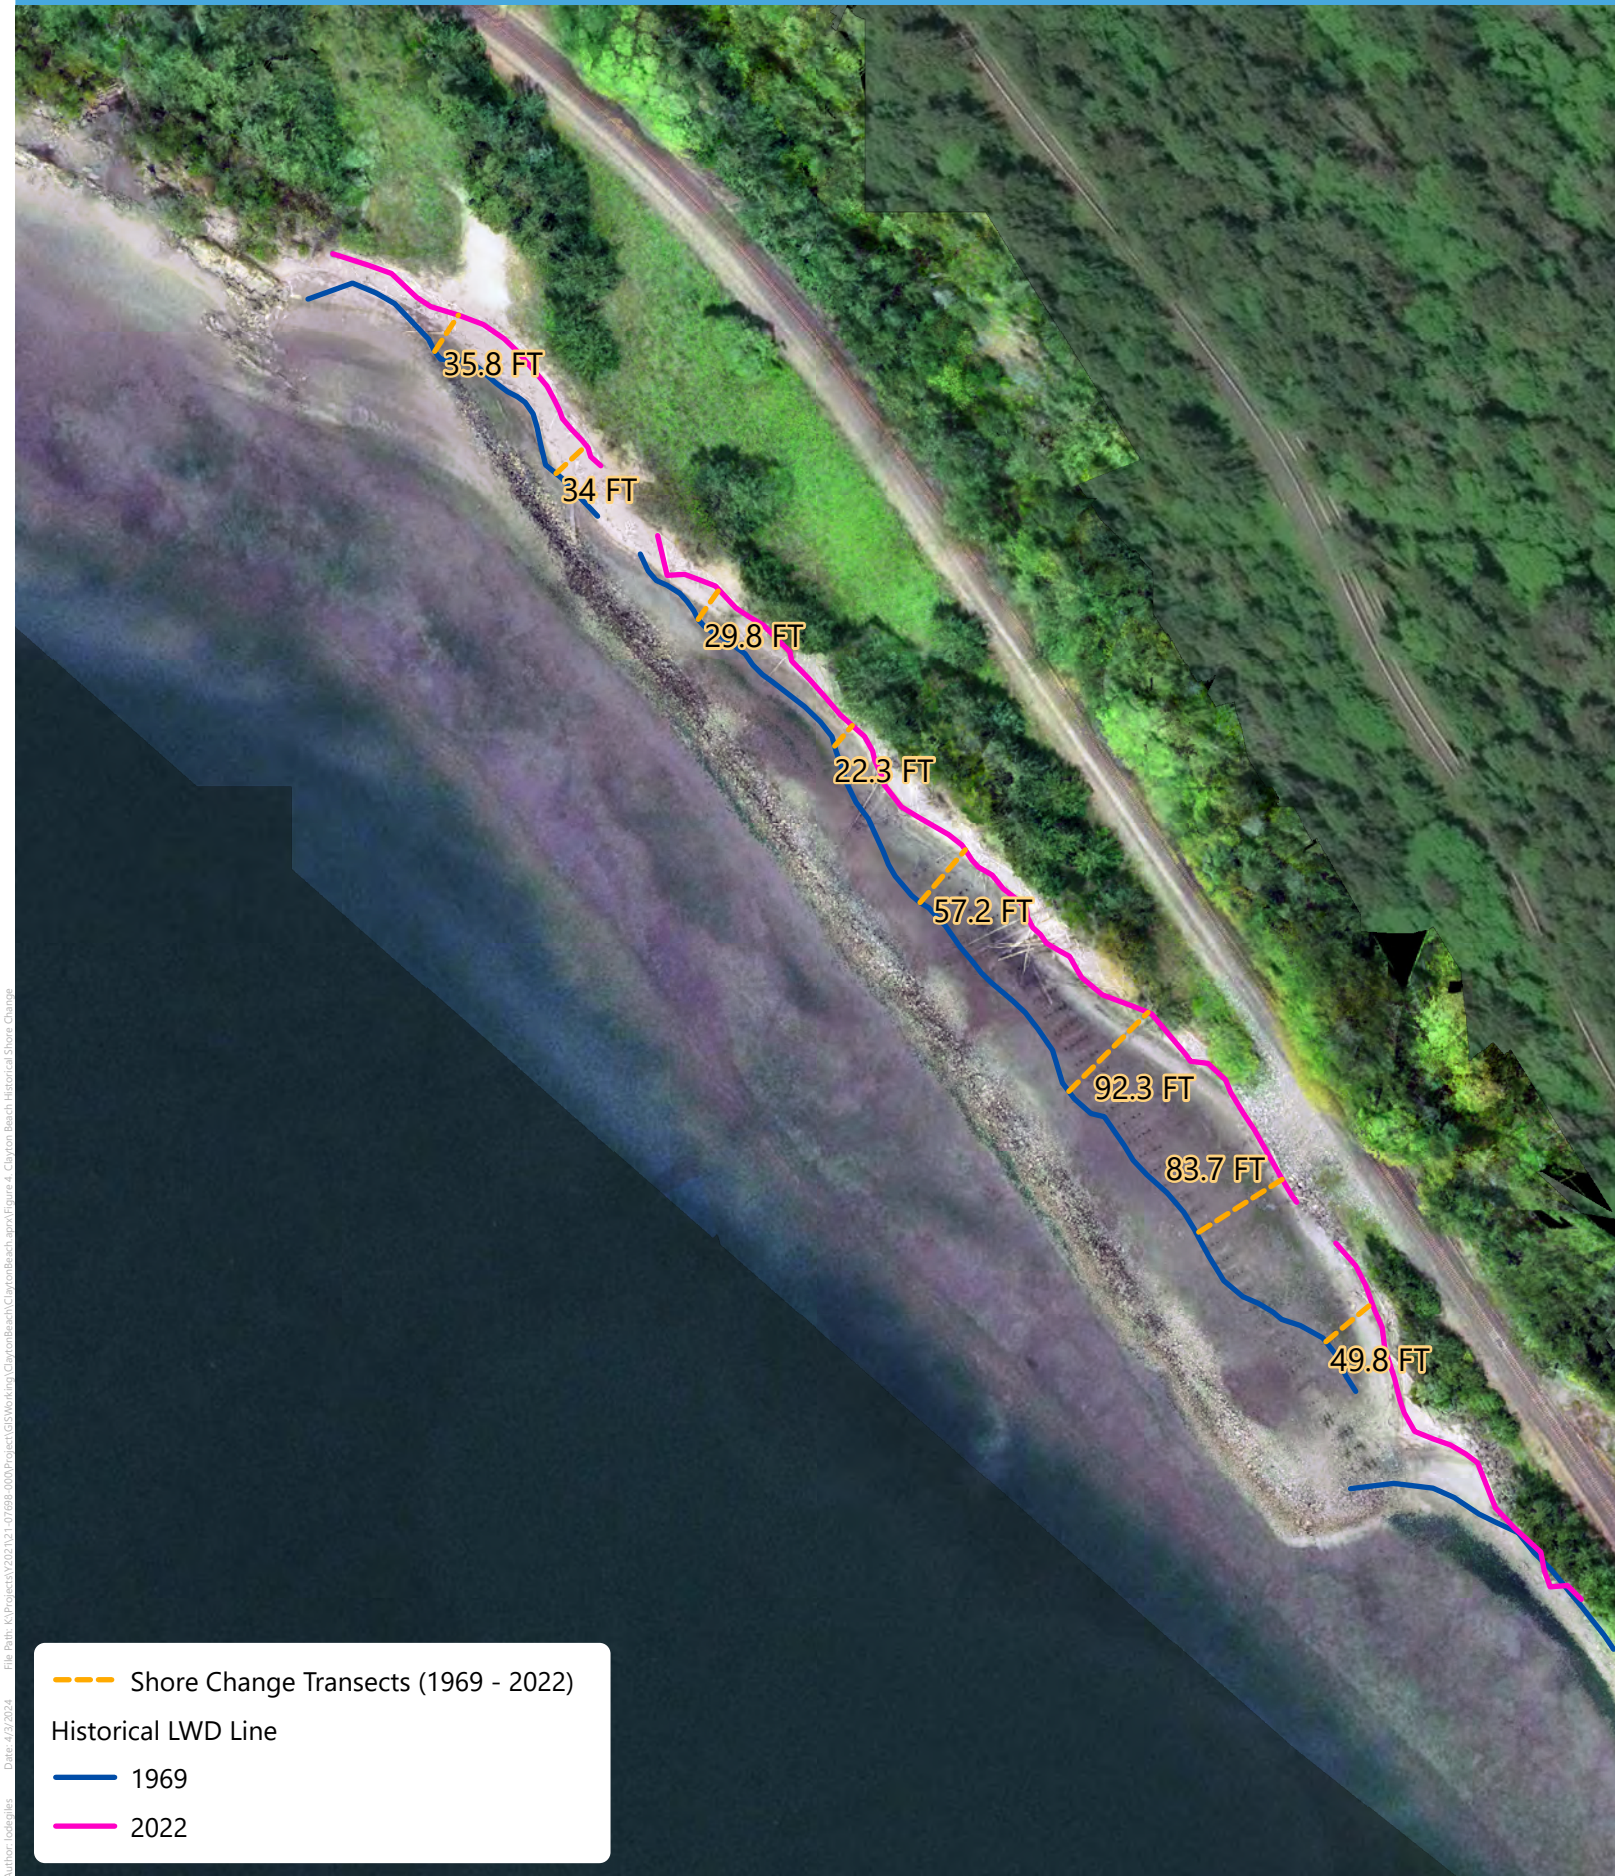
File Path: K:\Projects\2021-07684-000\Project\GIS\Working\ClaytonBeach.aprx Figure 4. Clayton Beach Historical Shore Change  
Date: 4/2/2024  
Author: lodes@herra.com

The following summary of nearshore geomorphic trends documents the recent evolution of the Clayton Beach based on air photo analysis. Results of these analysis documents a trend of consistent shoreline retreat of the historic fill placed for the B&SI Railway. The rate of erosion is relatively high. Figure 4 shows the retreat of the high-water shoreline over the past half-century where a maximum annualized erosion rate of approximately 1.2 feet per year and a minimum annualized erosion rate of approximately 0.2 feet per year were calculated. The greatest erosion rates were observed along the southern extent of the study area, which is outlined as an erosional hotspot. The fill placed for the B&SI Railway is dredged sediments which are predominantly sand that can be easily eroded. The increases in sea level, both observed and forecasted, resulting from climate change are likely to accelerate the erosion rates over the coming decades and beyond. It is foreseeable that B&SI Railway fill could be virtually eliminated by erosion over the next 50 years.

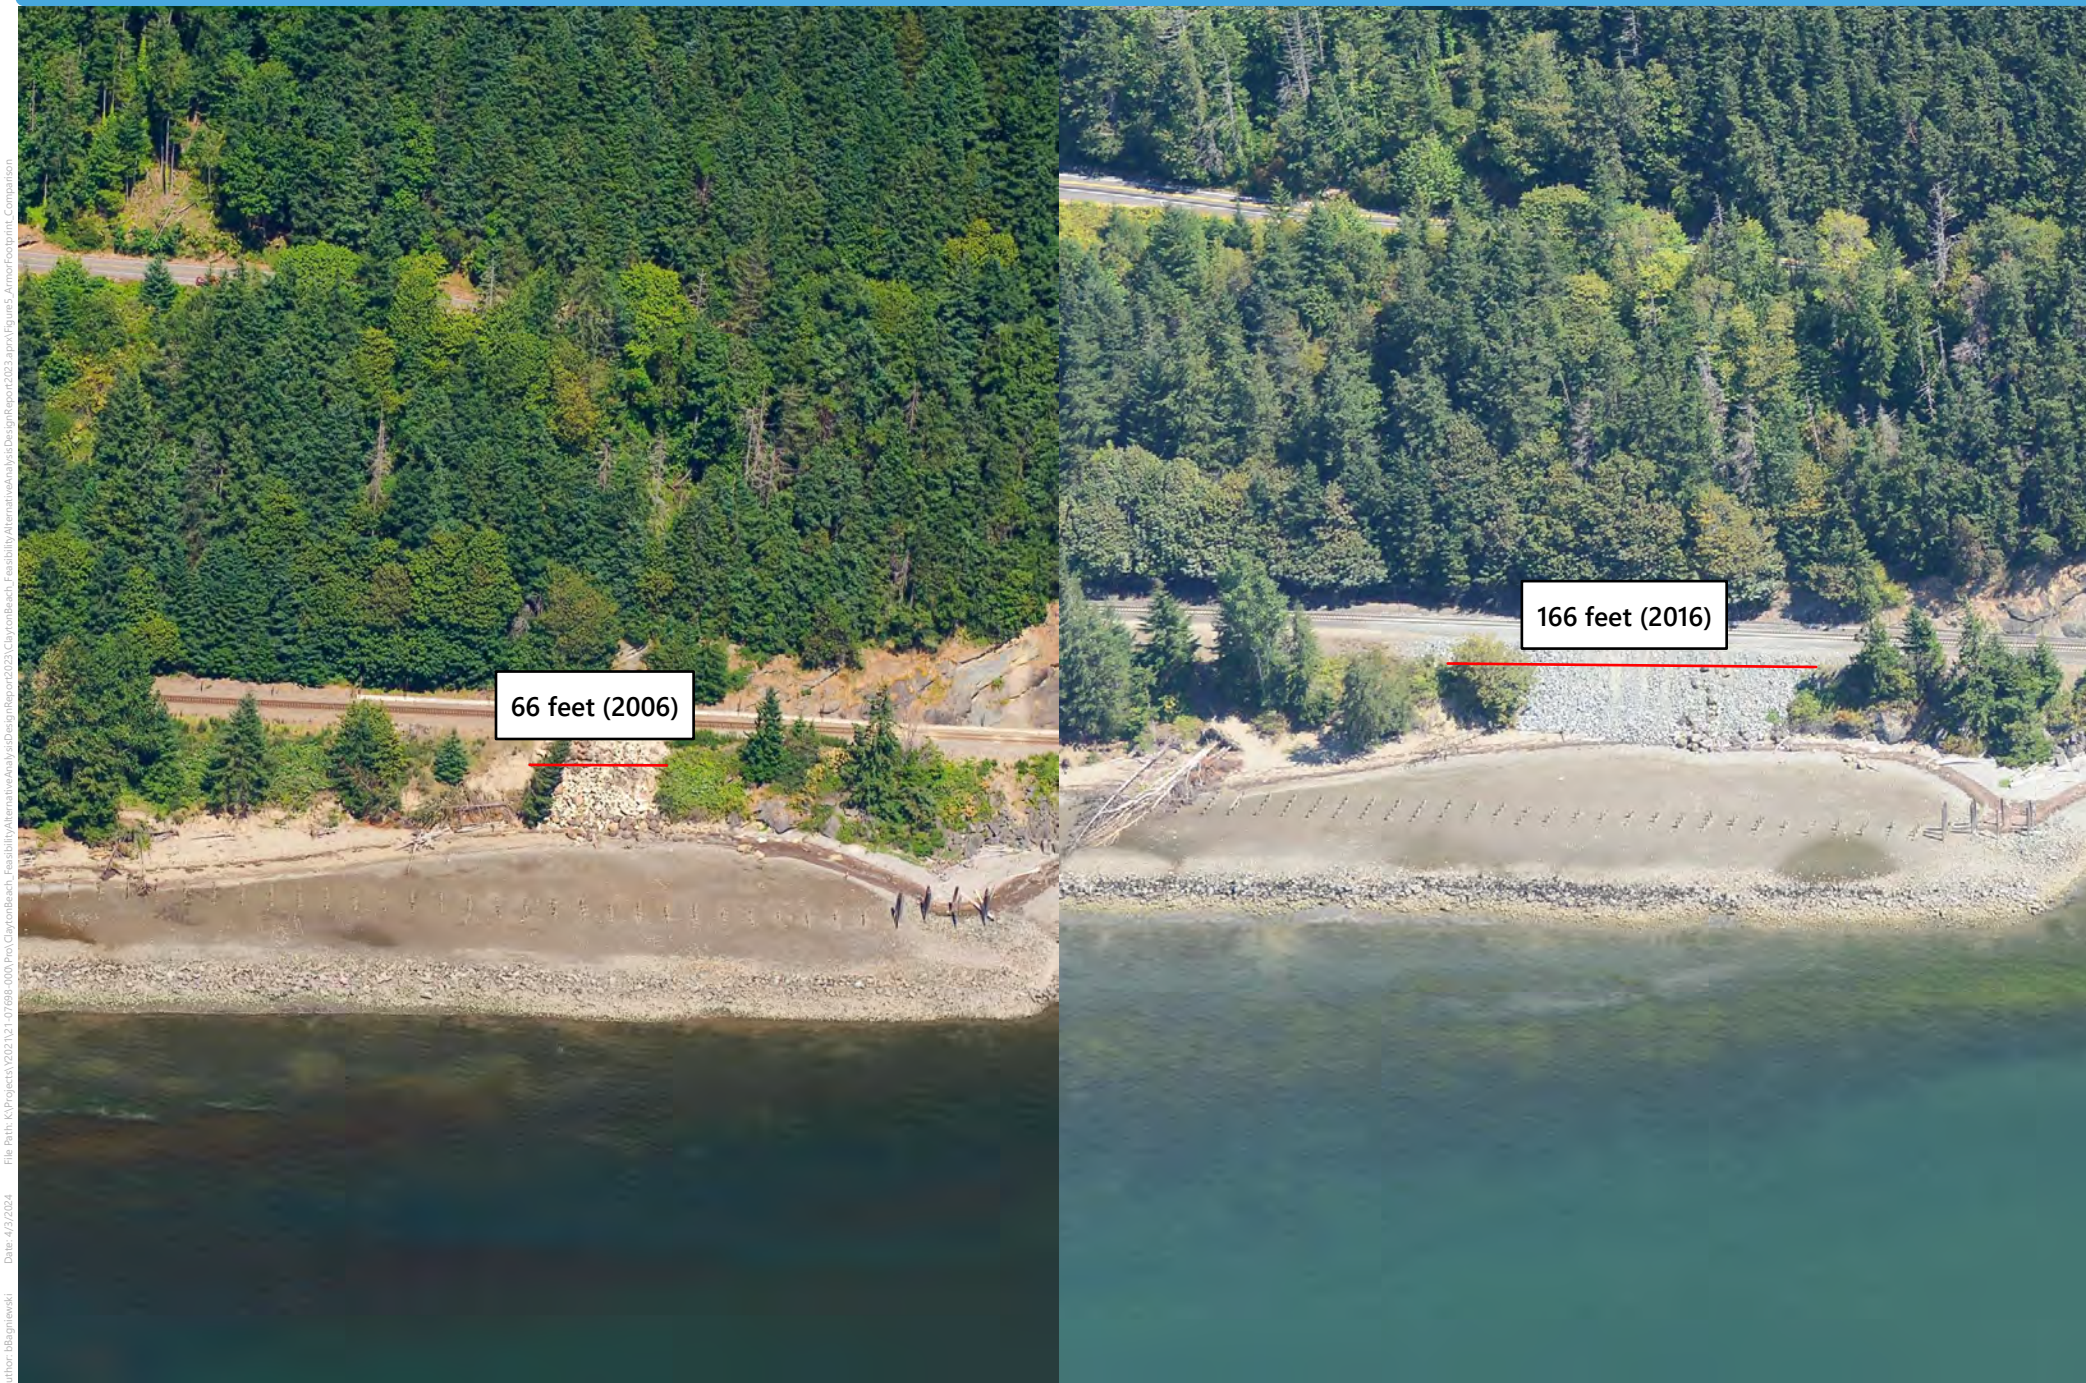
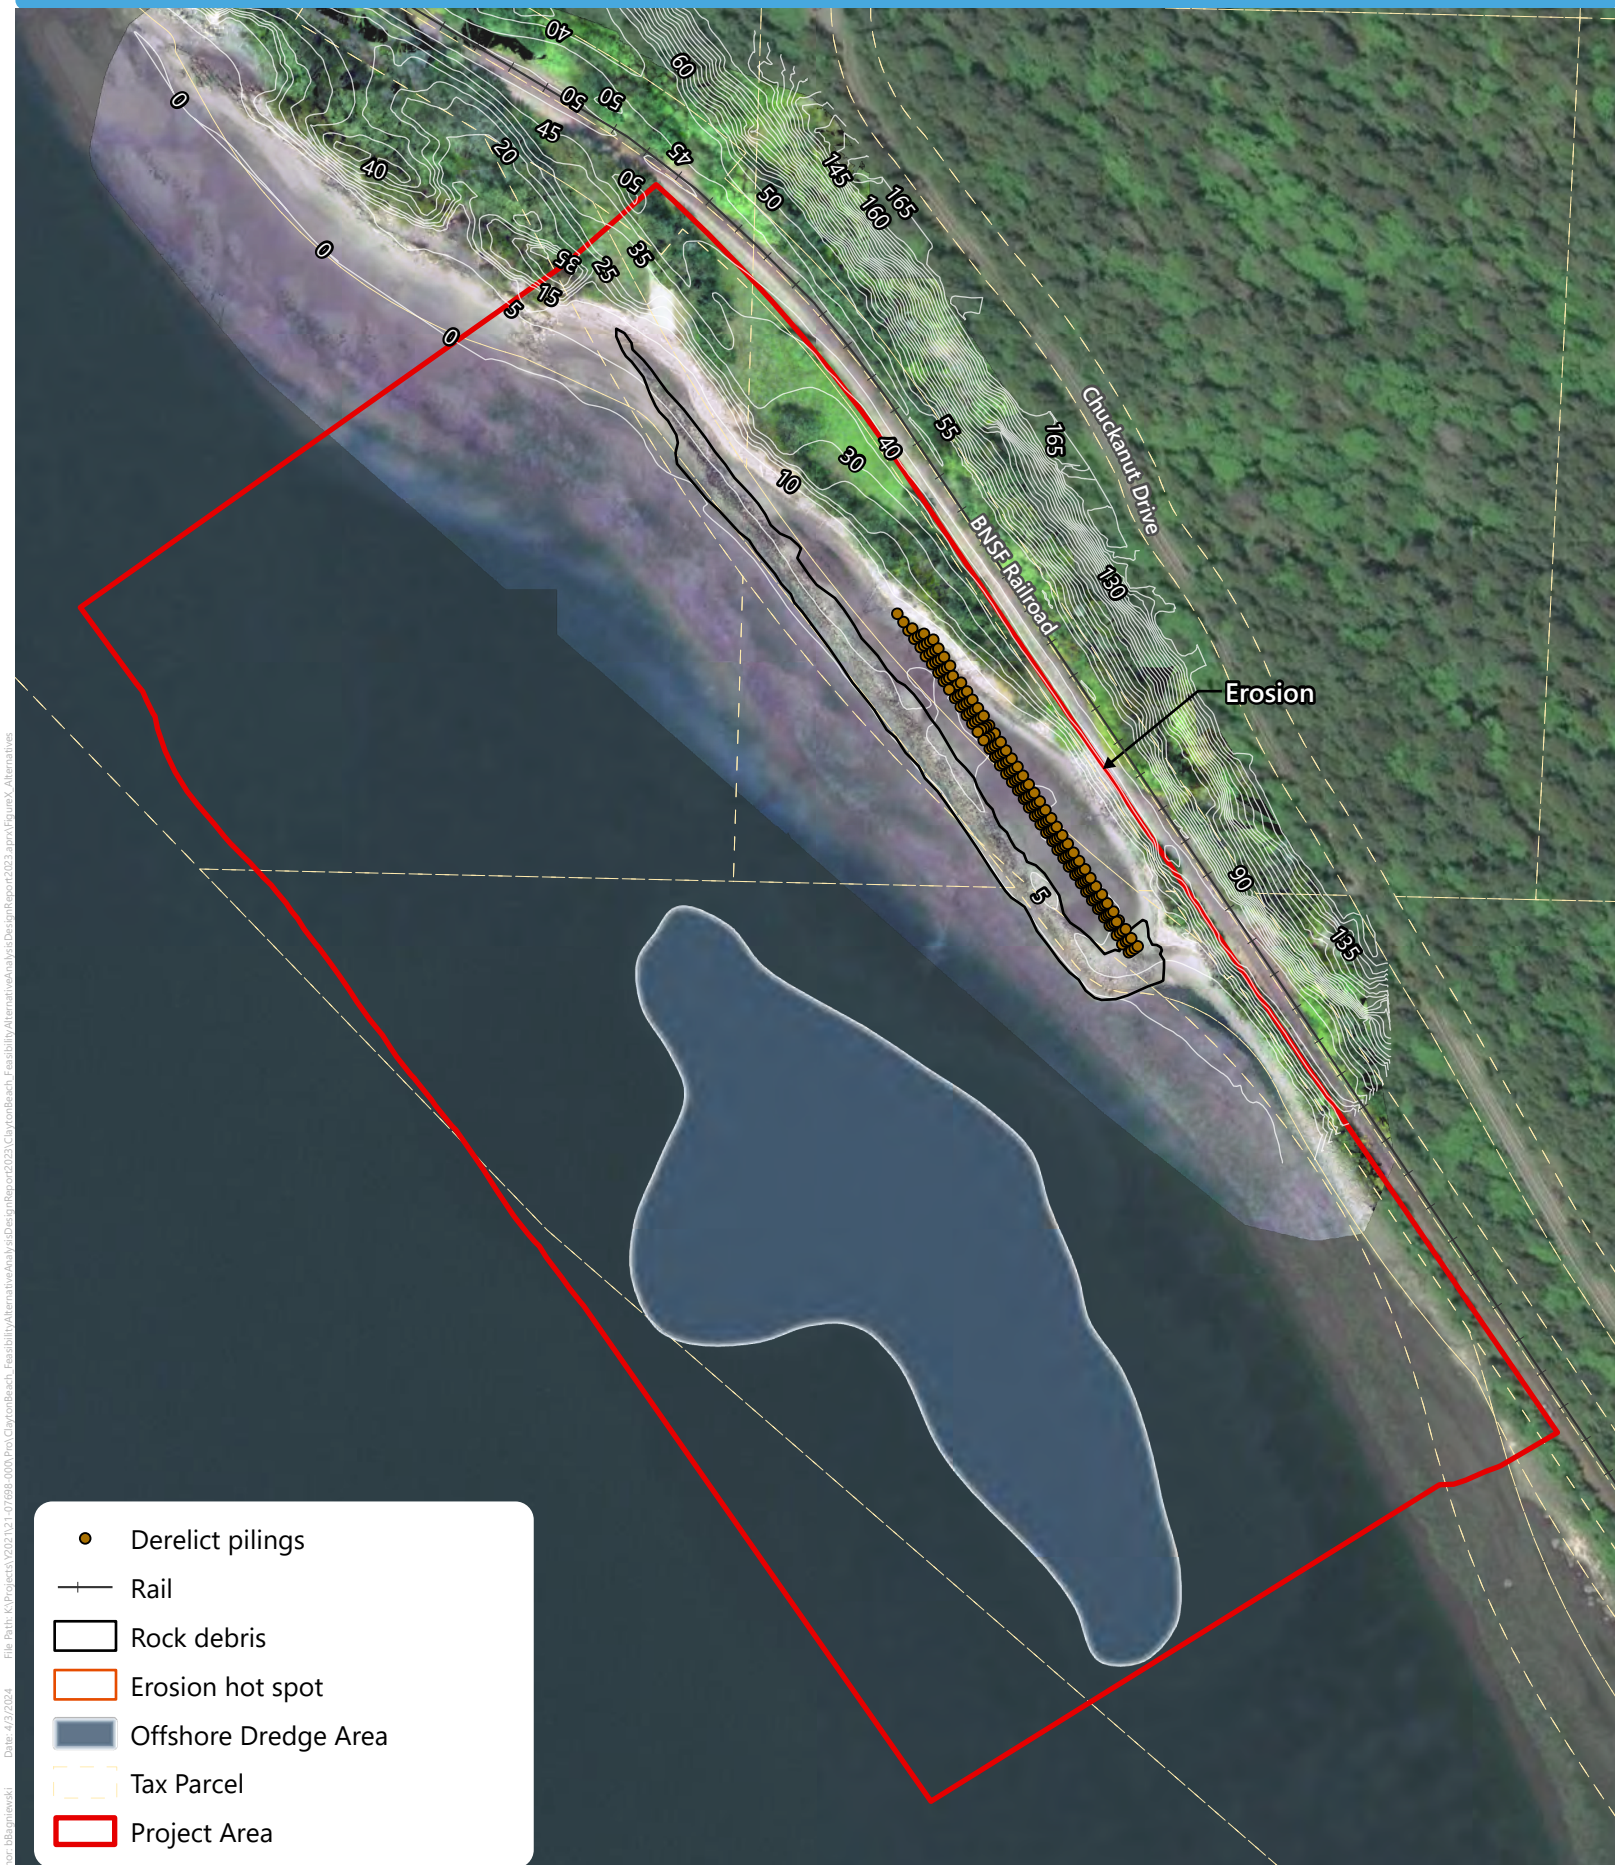
File Path: K:\Projects\2021-07684-000\_Proj\_ClaytonBeach\_FeasibilityAlternativeAnalysis\Design\Report\2023.aprx; Figure: Alternatives  
Date: 4/3/2024  
Author: bbaumgwick

Figure 5. Clayton Beach Restoration Design, Expanded Armor Footprint 2006 - 2016.

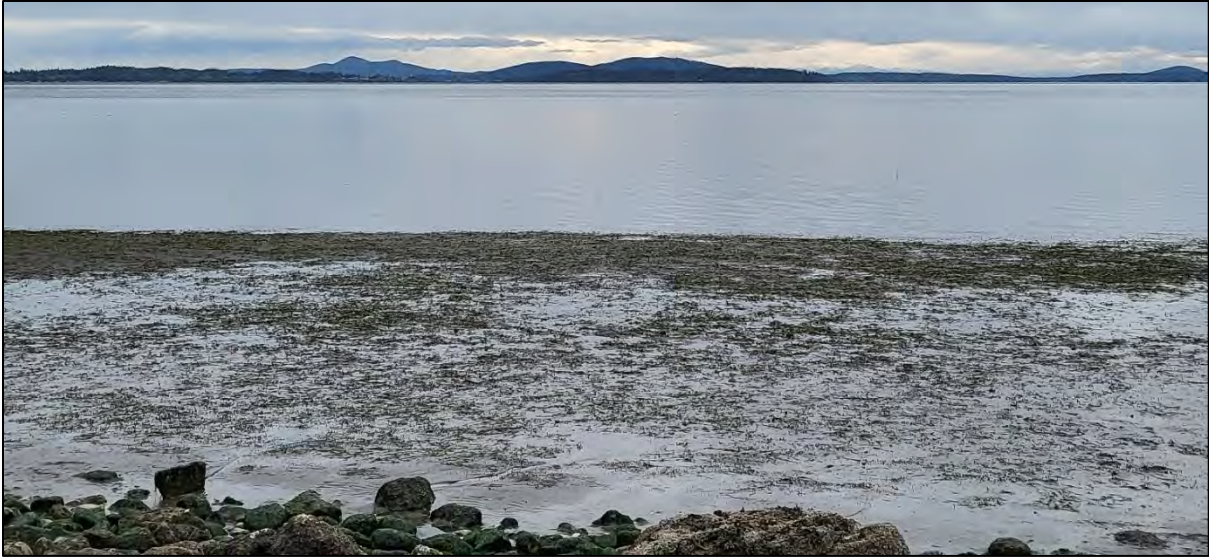
*Photo 7. View of eelgrass beds that are present waterward (west) of the outer edge of interurban rock debris and fill along the project area (Herrera, April 20, 2022).*

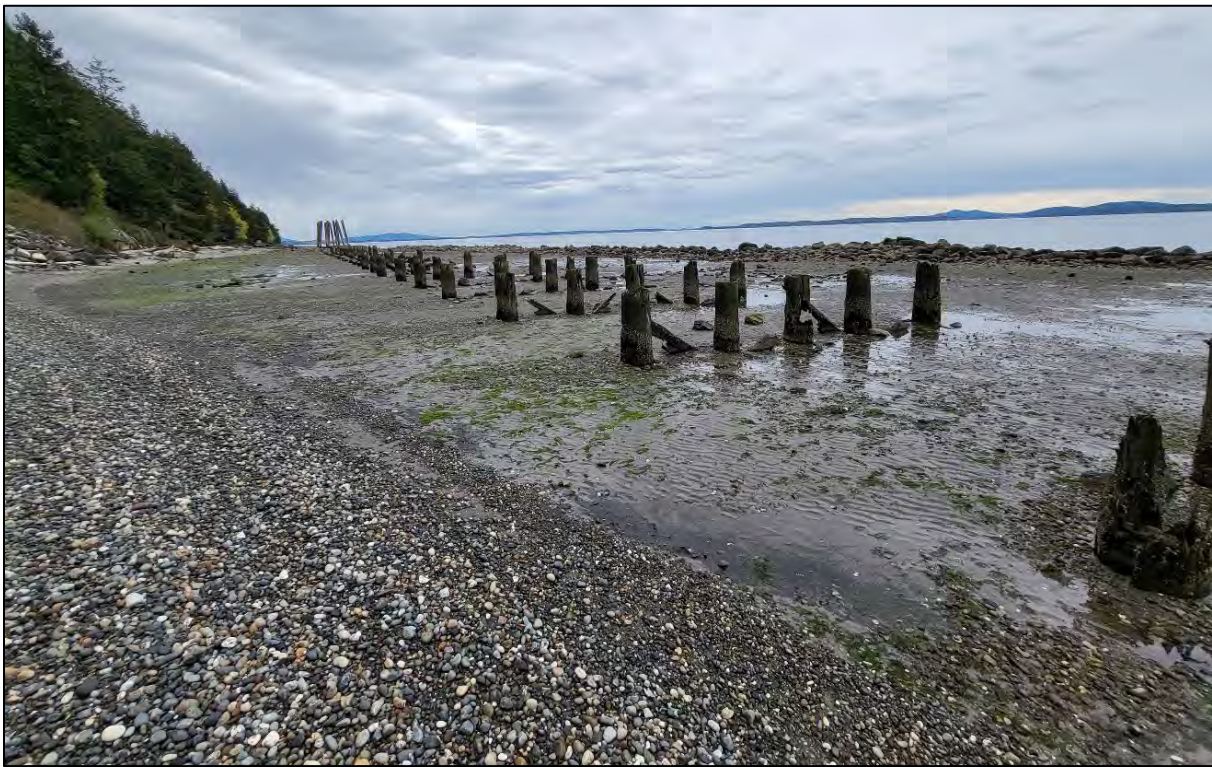
*Photo 8. View south of gravelly substrates in the upper intertidal zone at Clayton Beach (Herrera, April 20, 2022).*

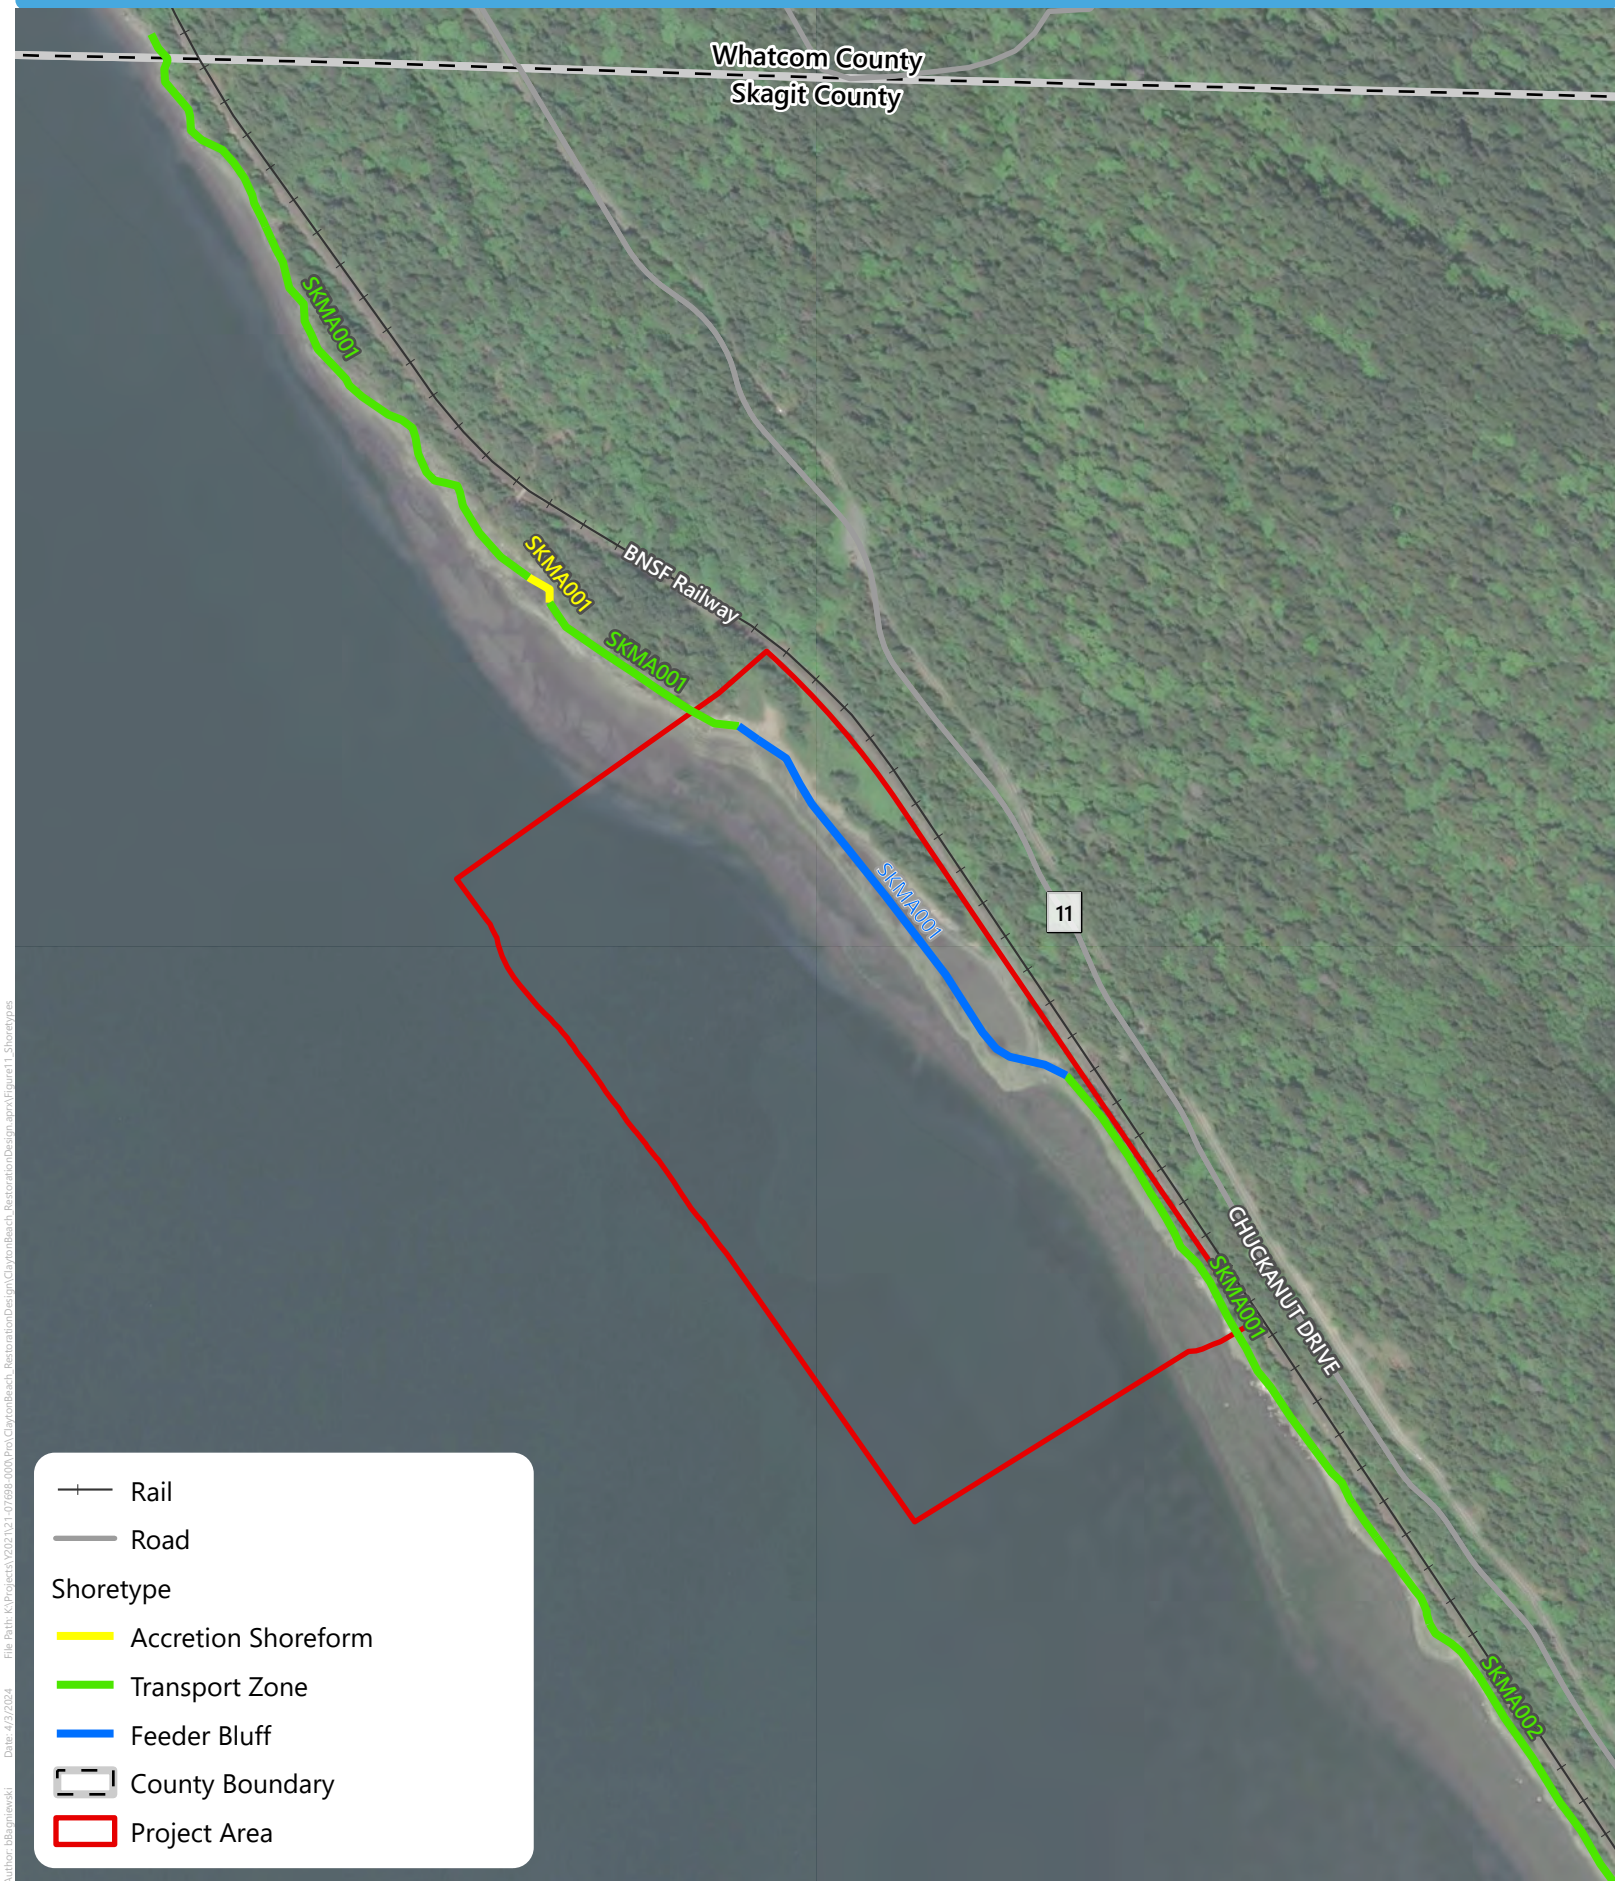
File Path: K:\Projects\2021-07684-000\Proj\ClaytonBeach\_RestorationDesign\Design.aprx\Figure11\_Shoretypes  
Date: 4/3/2024  
Author: bBagniewski

Clayton Beach was originally mapped as a feeder bluff (Figure 12, MacLennan et al. 2013) with waterward shoreline armor. The eroding bank, comprised of dredged fill does provide sediment to the nearshore environment; however, the mappers were unaware of the scale and nature of dredge and fill history at the site at the time of the mapping. Northward net shore-drift occurs through this reach of shore (SKMA001, Figure 13; MacLennan et al. 2013). At Clayton Beach, much of the sediment that erodes from the bank is limited in the extent of transport by the bedrock exposures found north of the study area, though some sediment transport likely occurs waterward of the bedrock. The erosion of the bank is valuable to the nearshore environment as it is one of the few intact sources of sediment in this drift cell. No appreciable drift is mapped north of Clayton Beach, due to the bedrock geology.

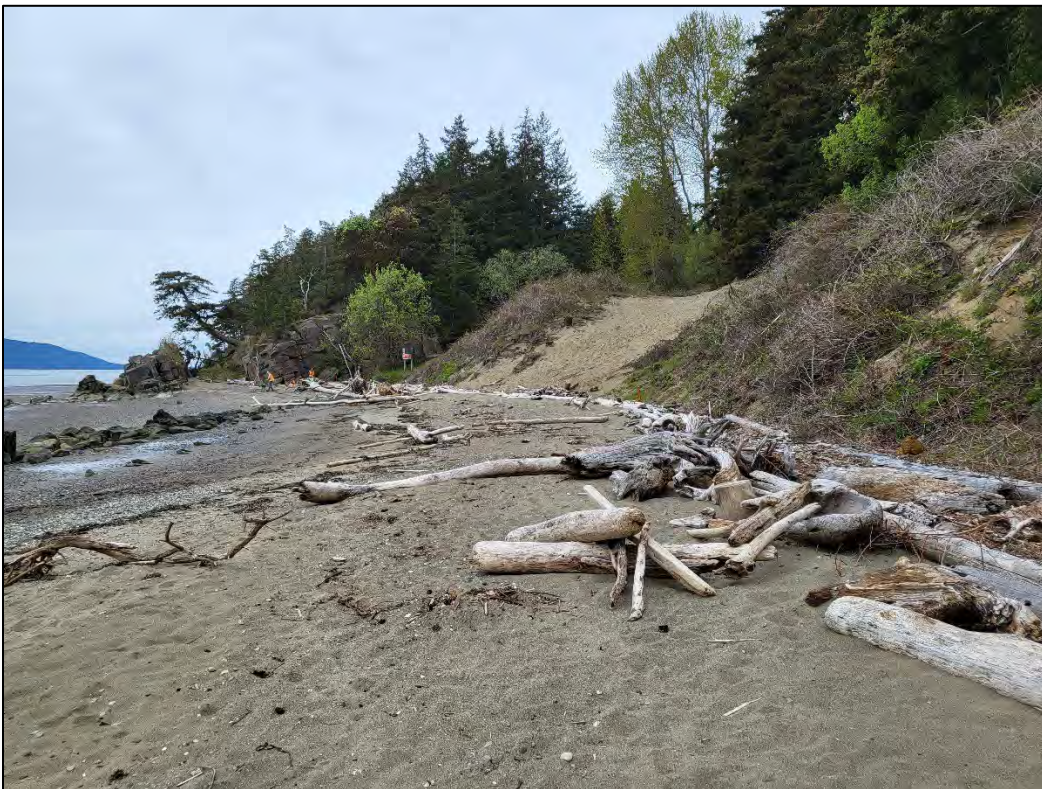
Photo 9. View of backshore along the Clayton Beach restoration area. The headland to the north of the site and the mountain slopes above the BNSF railroad tracks and Chuckanut Drive are forested. (Herrera, April 20, 2022).

Driftwood logs and wrack are deposited along the toe of the slope (Photo 9). The logs are subject to movement with the tides, during storm events, and from park visitors that commonly build driftlog structures in the backshore.

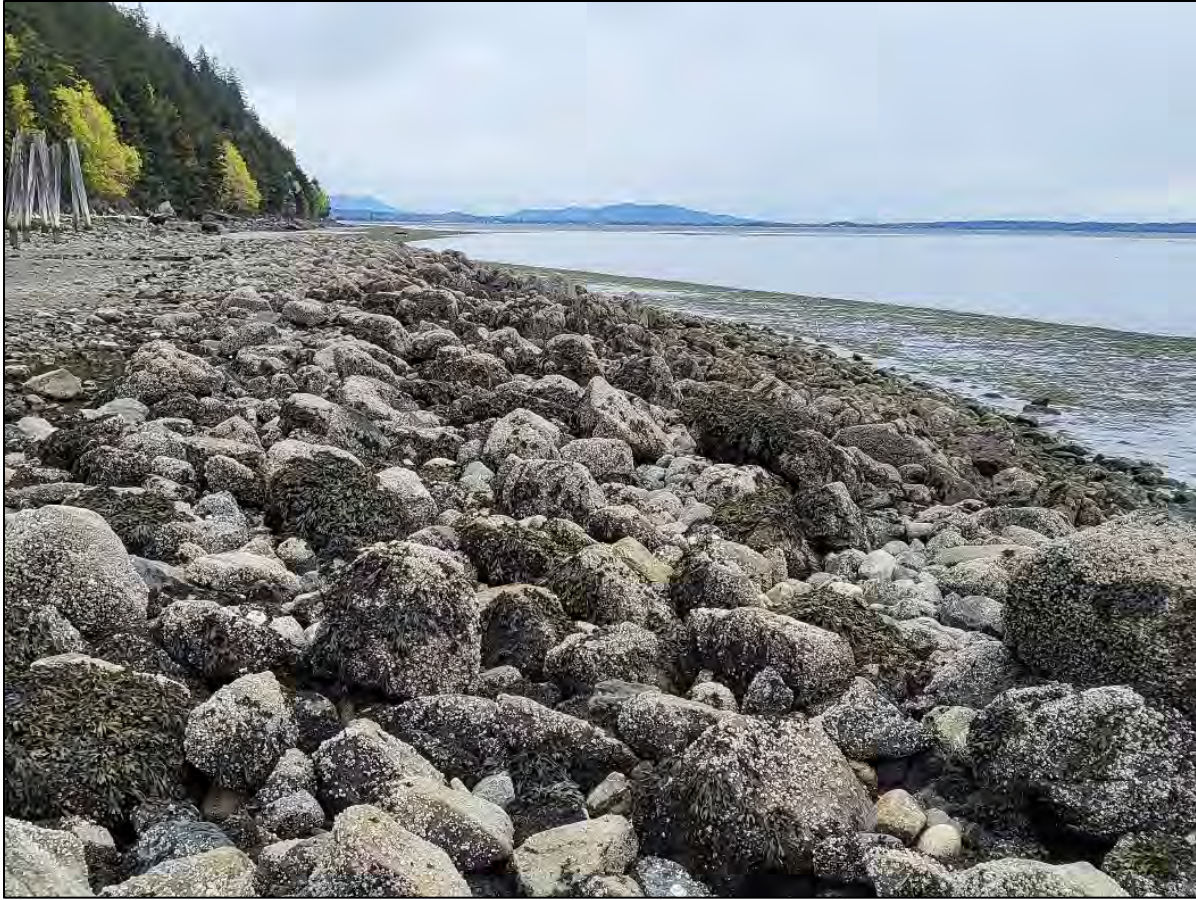
*Photo 11. All three alternative restoration designs will remove artificially placed rocks and regrade the perched beach to more natural conditions conducive to eelgrass growth and forage fish habitat. (Herrera, April 20, 2022).*

Three alternative nearshore restoration designs were developed for consideration for the project (Figures 15, 16 and 17). All three designs include the removal of fill, rock debris, crib wall, and creosote-treated piles from the nearshore and restoration of the marine riparian ecotone. The beach would be nourished with a mix of sand and gravel that resembles native beach material from a local reference beach. The upper beach and backshore will include a storm berm intended to help absorb wave energy and protect the landward BNSF rail causeway. The storm berm and landward backshore would be vegetated with salt tolerant plants known to succeed in these environments, such as dune grass (*Leymus mollis*). Restoration of the marine riparian zone will entail removal of several non-native and invasive species and installation of native plants in the uplands.

In all alternatives, rock and suitable fill material that has been removed from the upper beach will be reused to rebuild elevation and eventually fill the dredge trench located directly offshore of the site, following approval from regulatory agencies. Additional sand will need to be imported to complete filling the expansive hole and to restore the natural bathymetry of the sub-tidal, natural wave conditions, and the likely historical spatial extent of eelgrass beds. Filling the dredge hole is a very important element of the restoration and the long-term sustainability of Clayton Beach restoration and the BNSF railway. Wave modeling results revealed that the deep water created by the dredge hole focuses wave dissipation along the toe of the bank, which appears to be a driving force in the erosional hotspot located along the south shore of the beach. The hole also provides an area for larger fish and mammals to prey on migrating juvenile salmonids.

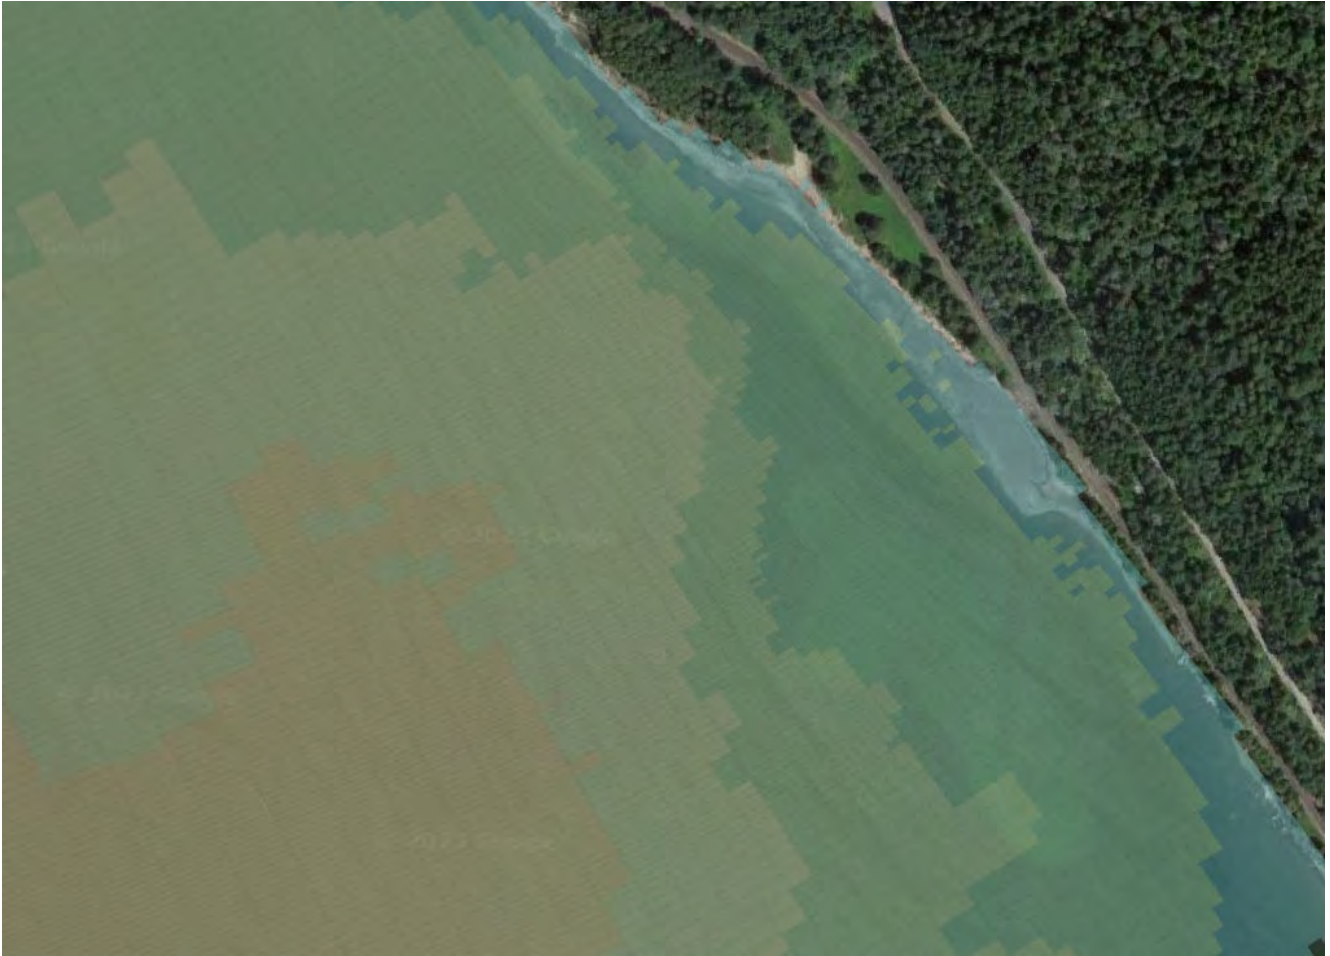
Figure 27. Significant Wave Heights at 0.33 Feet Average Wave Height, Existing Conditions (model label "Dredged").

Note the encroachment of higher waves on Clayton Beach.

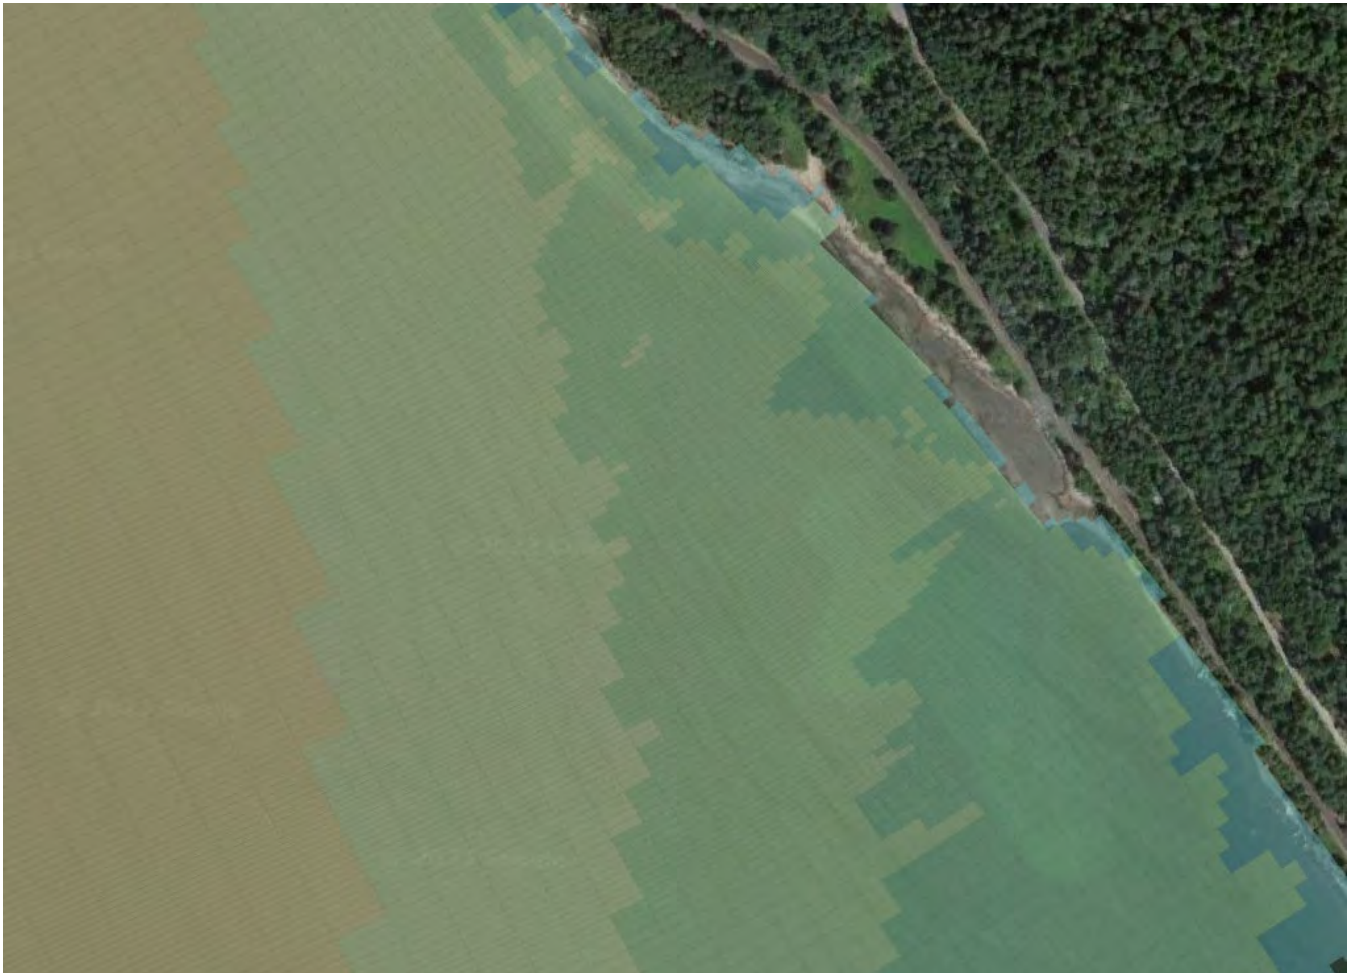
Figure 28. Significant Wave Height at 3.28 Average Wave Height, Restored and Filled Surface (model label "Alt\_Filled").

The restored beach buffers the high waves away from infrastructure.
