# Clayton Beach Restoration Feasibility and Alternative Analysis Design Report

## Skagit County, Washington

Prepared for  
Northwest Straits Conservation Foundation  
Prepared by  
Herrera Environmental Consultants, Inc.

May 2, 2024

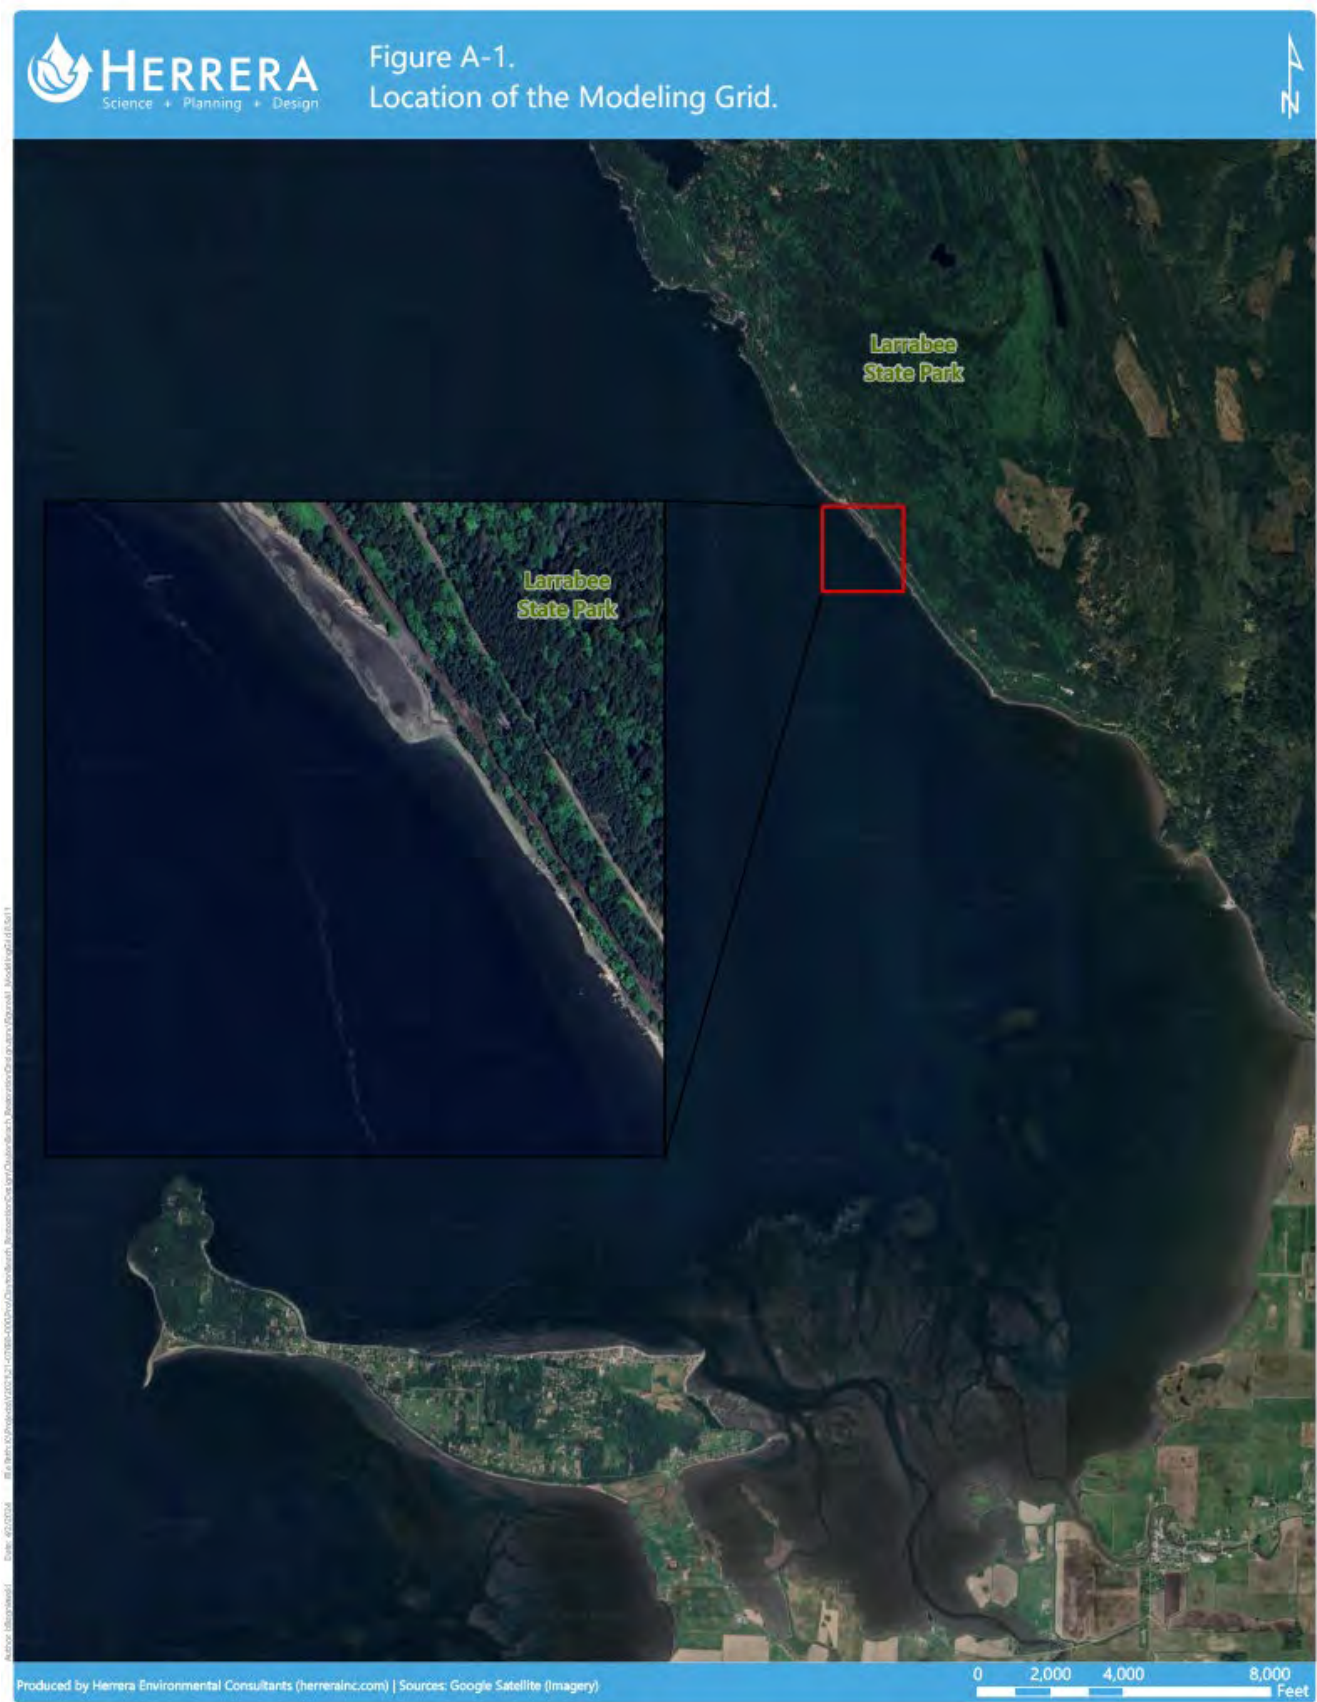
Figure A-1. Location of the modeling grid.

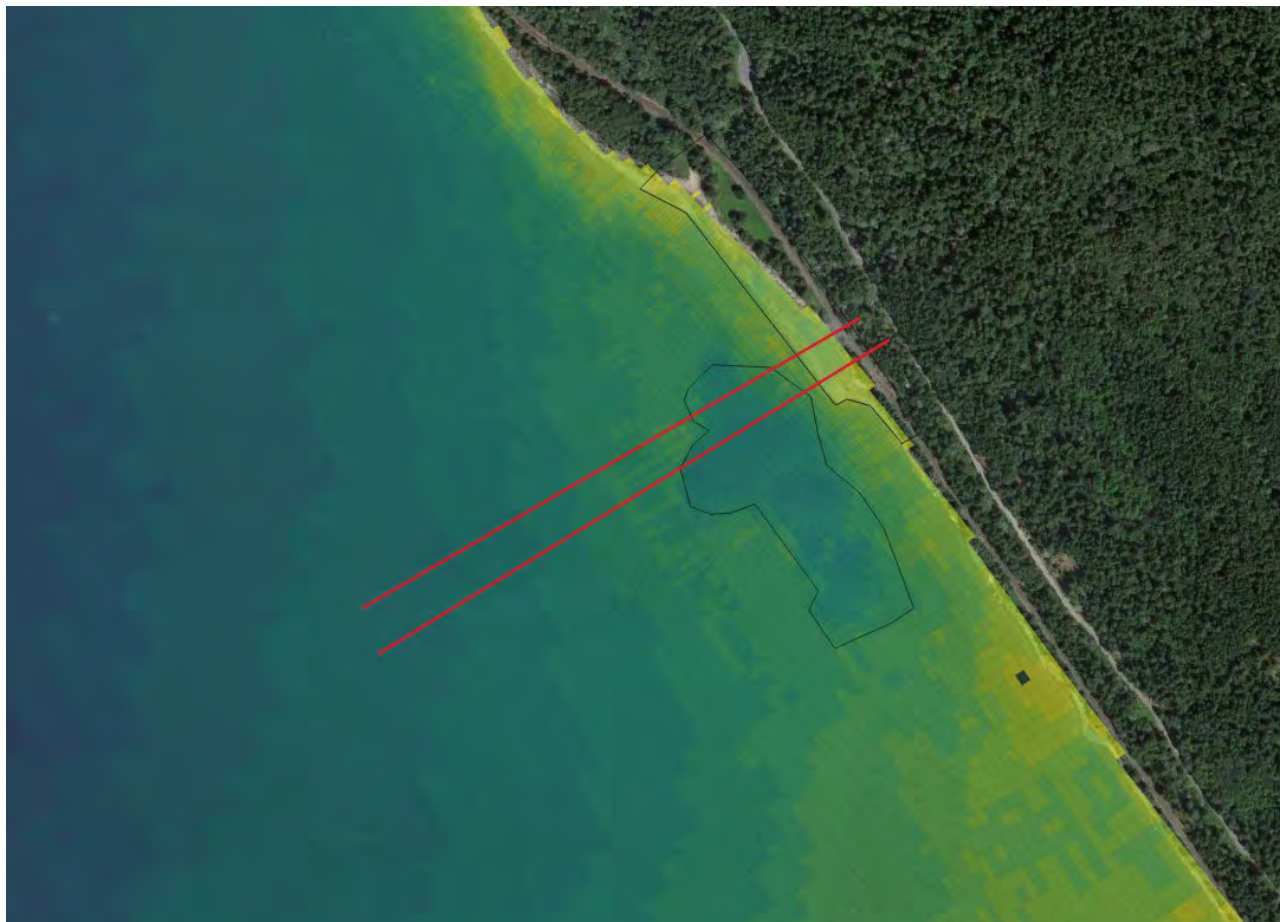
Figure A-5. Alternative restored surface, dredged area included (model label "Alt\_Dredged"), at low tide. Note that in the restored surface the model edge is pushed seaward, reflecting a raised and nourished beach.

Below (Figures A-4 – A-7) are renderings of all potential surface bathymetries, pictured at 0 feet of tidal depth. Clayton Beach and the offshore dredged trench are outlined in black. Included are the two profiles placed for extracting model data, drawn in red.

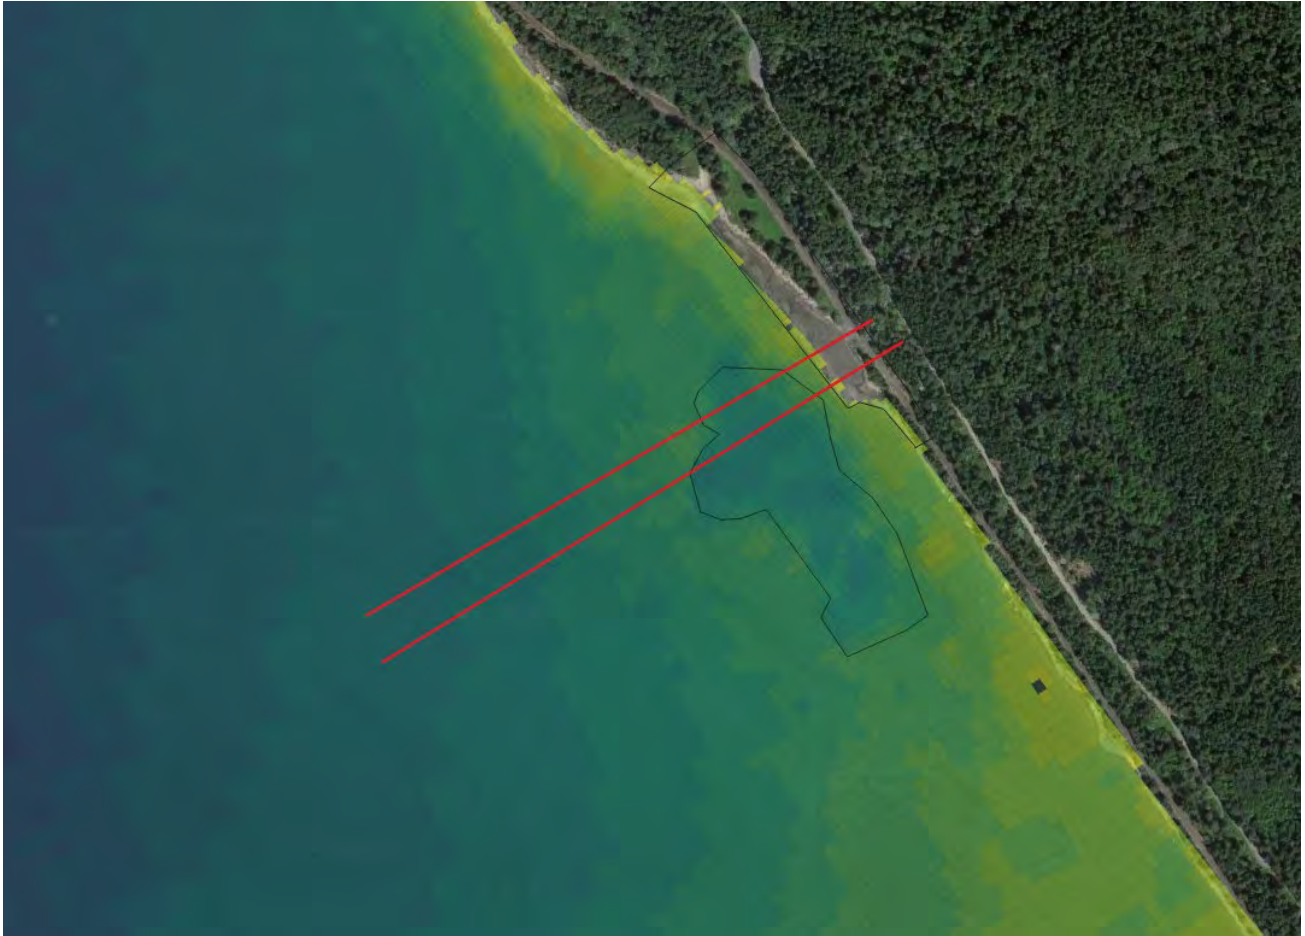
Figure A-6. Existing surface, dredged area filled (model label "Filled"), at low tide. The dredged area no longer displays the deeper bathymetry present in Figures A-4 and A-5. Note that the model extends well over the beach.

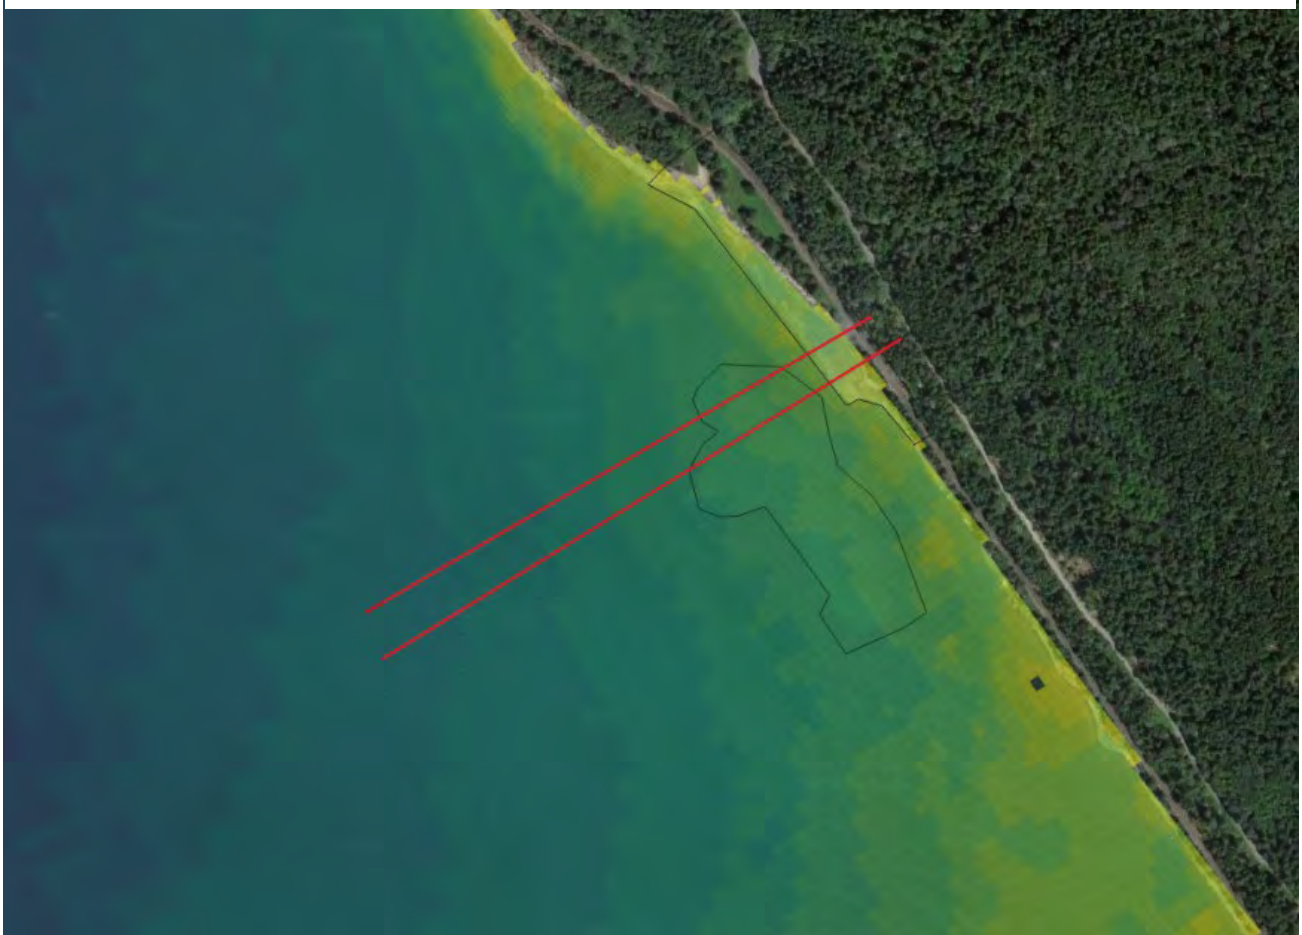
Figure A-7. Alternative restored surface, dredged area filled (model label "Alt\_Filled"). Note that in the restored surface the model edge is pushed seaward, reflecting a raised and nourished beach.

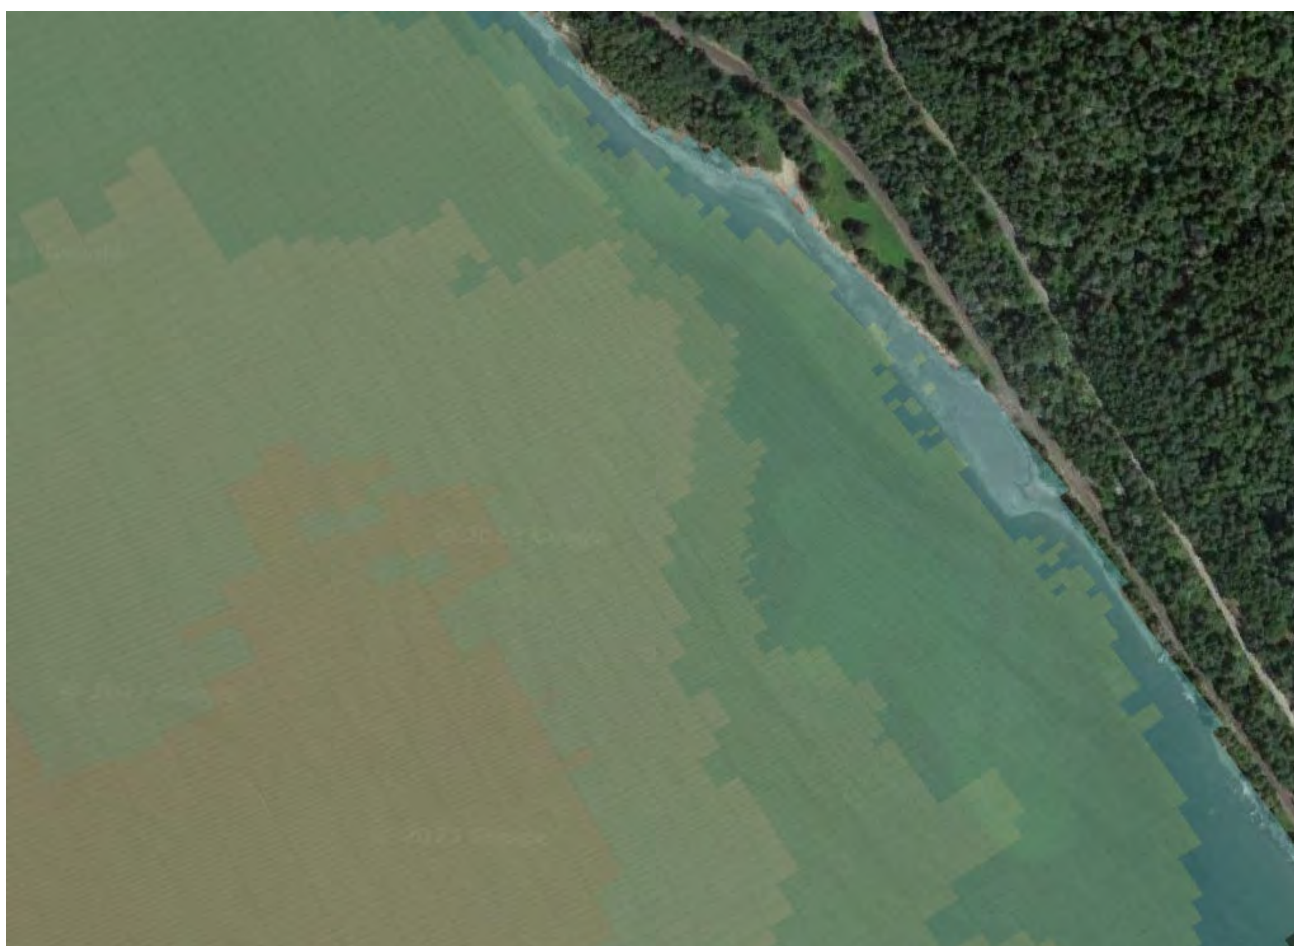
Figure A-20. Significant wave height at 3.28 feet average wave height, existing conditions (model label "Dredged"). Note the extended reach of significant waves into the nearshore area at Clayton Beach, particularly over the dredged trench.

Significant wave height is a value that traditionally indicates the average height of the highest 33 percent of measured waves. As significant wave height is strongly associated with depth, the dredged trench offshore affects nearshore wave height. In the models run on filled beach surfaces, highest wave heights and the subsequent risk of erosion are shifted offshore when compared with dredged conditions. Figures A-19 – A-22 show model outputs of low and high wave values on dredged and filled surfaces. When wind and wave values are low overall wave height is low, and waves display increased heights nearer to shore when wind and wave values are high.

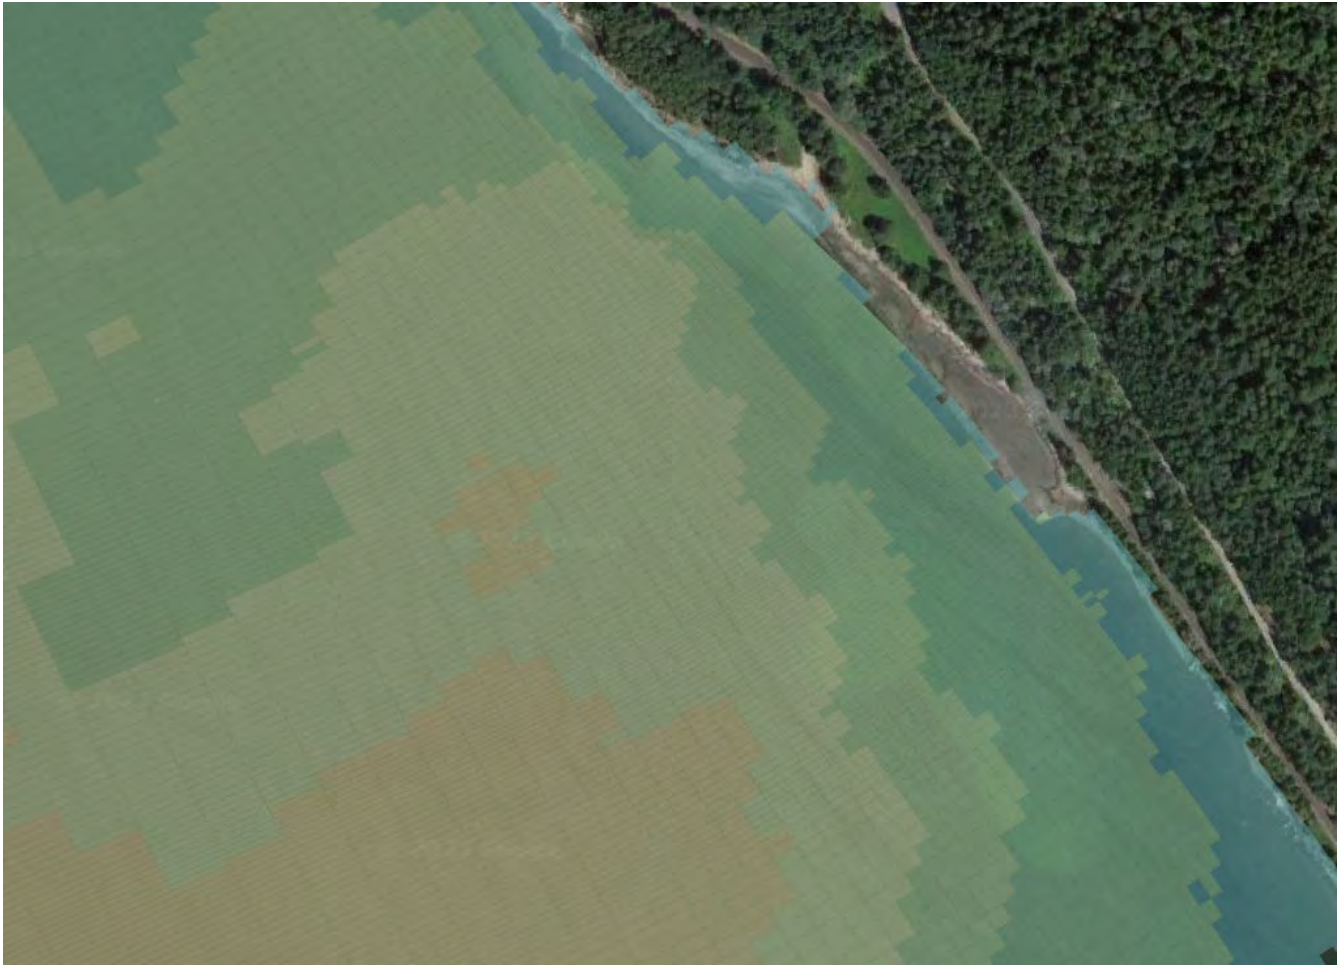
Figure A-21. Significant wave height at 0.33 average wave height, restored and filled conditions (model label "Alt\_Filled"). High significant wave heights have been shifted offshore.

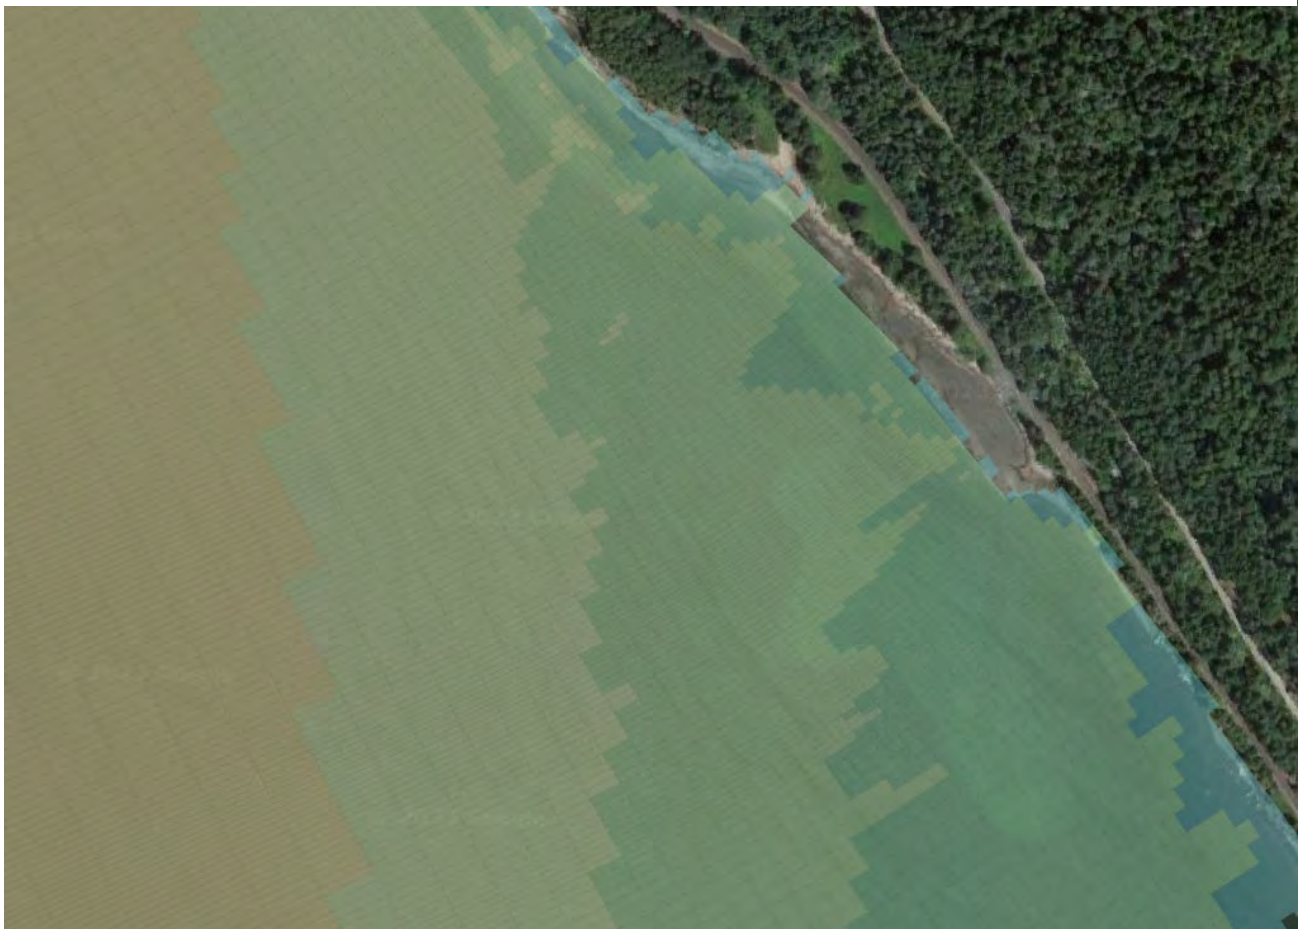
Figure A-22. Significant wave height at 3.28 average wave height, restored and filled surface (model label "Alt2\_Filled"). The restored beach buffers the high waves away from infrastructure.

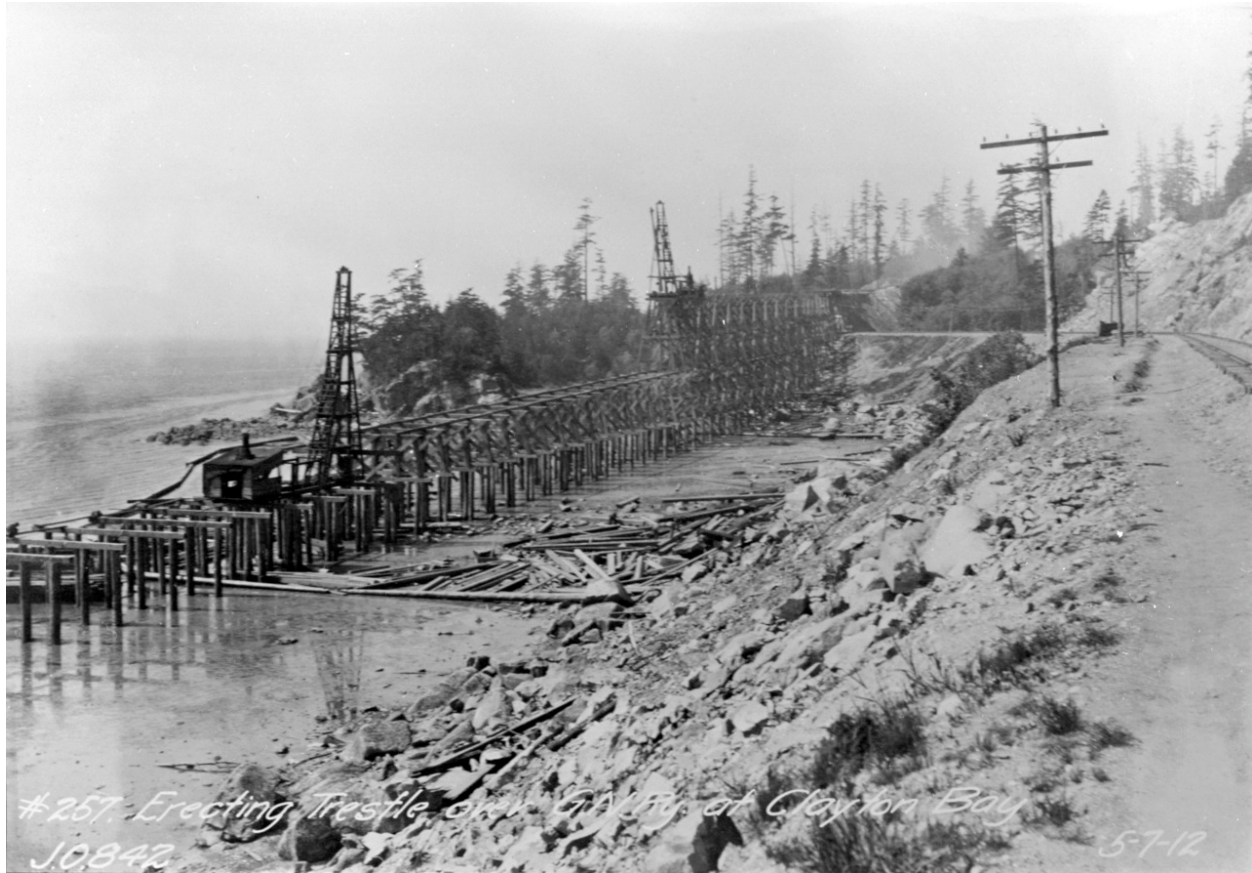
Figure 2. Clayton Beach 1912 Trolley Trestle Construction. Photograph taken from the south, looking north. Photo from Western Washington University Heritage Resources Archive.

The Northwest Straits Foundation (NWSF) and partners are currently assessing the feasibility of removing 1,300 linear ft. of armoring rock (riprap) and remnant wooding pilings from the nearshore at Clayton Beach (Figure 1). This restoration targets the removal of structure placed at the site in the early 1900's which historically supported an electric trolley for commuter transport from Bellingham to Mt. Vernon WA. This route was known as the Bellingham and Skagit Interurban railway and operated from 1912 to 1928 (Figure 2).

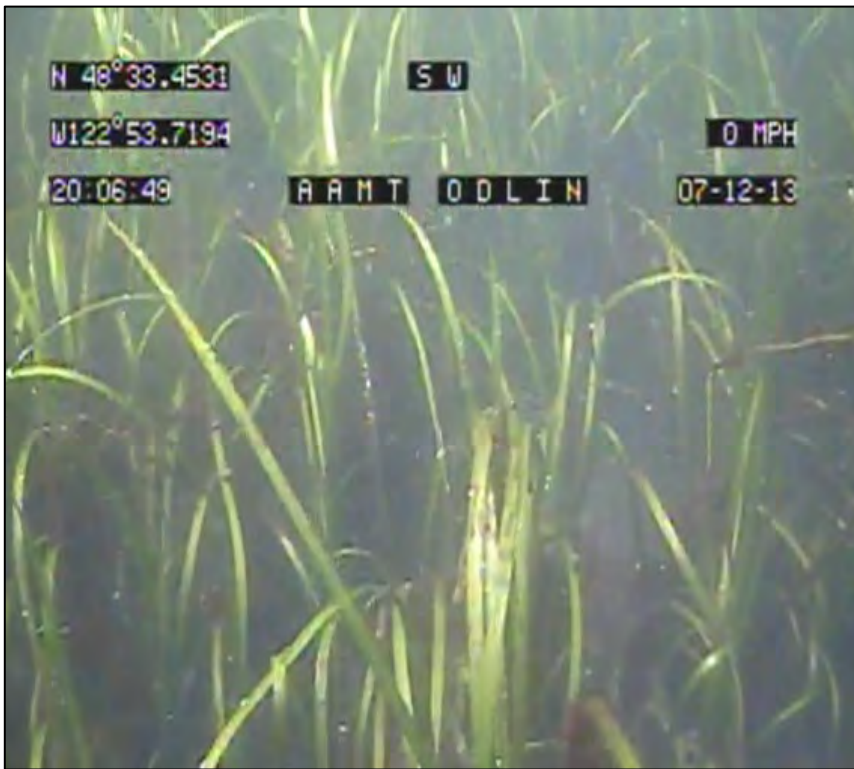
Figure 6. View of real-time video collection and attributes.

BioSonics software interprets a unique sound return for eelgrass; however, there are anomalous features that may be misinterpreted as eelgrass when post-processing (Sabot et al., 2002; Shuai Xu, 2019). To verify eelgrass presence, we collect underwater video along 10% of the transects surveyed. For these transects, video can be collected while the sonar is also running by towing a SeaViewer Sea-Drop 950 video camera weighted and suspended by line off the port side of the boat. In real-time, a SeaViewer Sea-Trak GPS overlay displays time and GPS locations onto the video image (Figure 6). Video data is recorded digitally on an SD card with a SeaViewer DVR-SD.

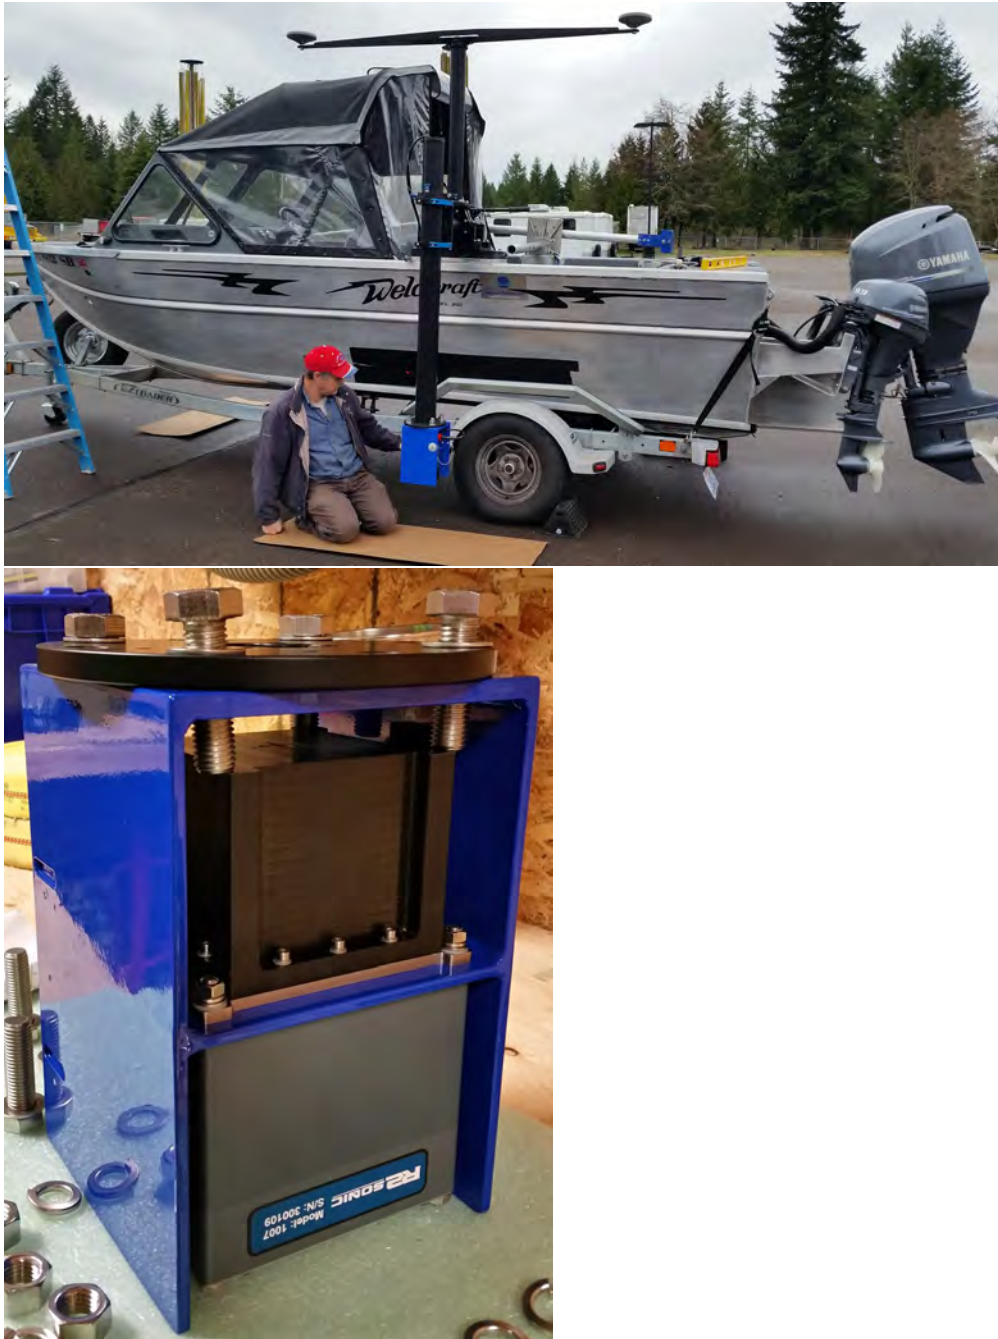
Figure 8. R2Sonic 2020 multibeam (bottom, grey), Applanix IMU (top, black), and mount (blue)

An R2sonic 2020 multibeam sonar and an integrated Applanix navigation system was utilized for bathymetry. The R2Sonic 2020 model is a small and light flat array multibeam unit that combines the transmitter and receiver into a single instrument. Position, heading, pitch, yaw, and roll are recorded with an Applanix Inertial Motion Unit (IMU) and Trimble GNSS positioning system. Using Applanix’s POS PAC software (Applanix Corporation 2021) DNR scientists collect raw motion and heading data in the field, process these observations in the office, and recalculate the entire survey’s data for high-accuracy three dimensional spatial locations.

Data was collected at a 400 kHz frequency, with a beam width of 130 degrees. At least fifty percent data overlap was collected between tracks. The survey was planned and carried out with QINSY software by QPS Maritime Software Solutions. Full water column sound speed measurements are collected with a Sontek CastAway CTD every two hours. The CastAway rapidly measures density, pressure, salinity, conductivity, and temperature and calibrates sound speed with the multi beam’s surface sensor.

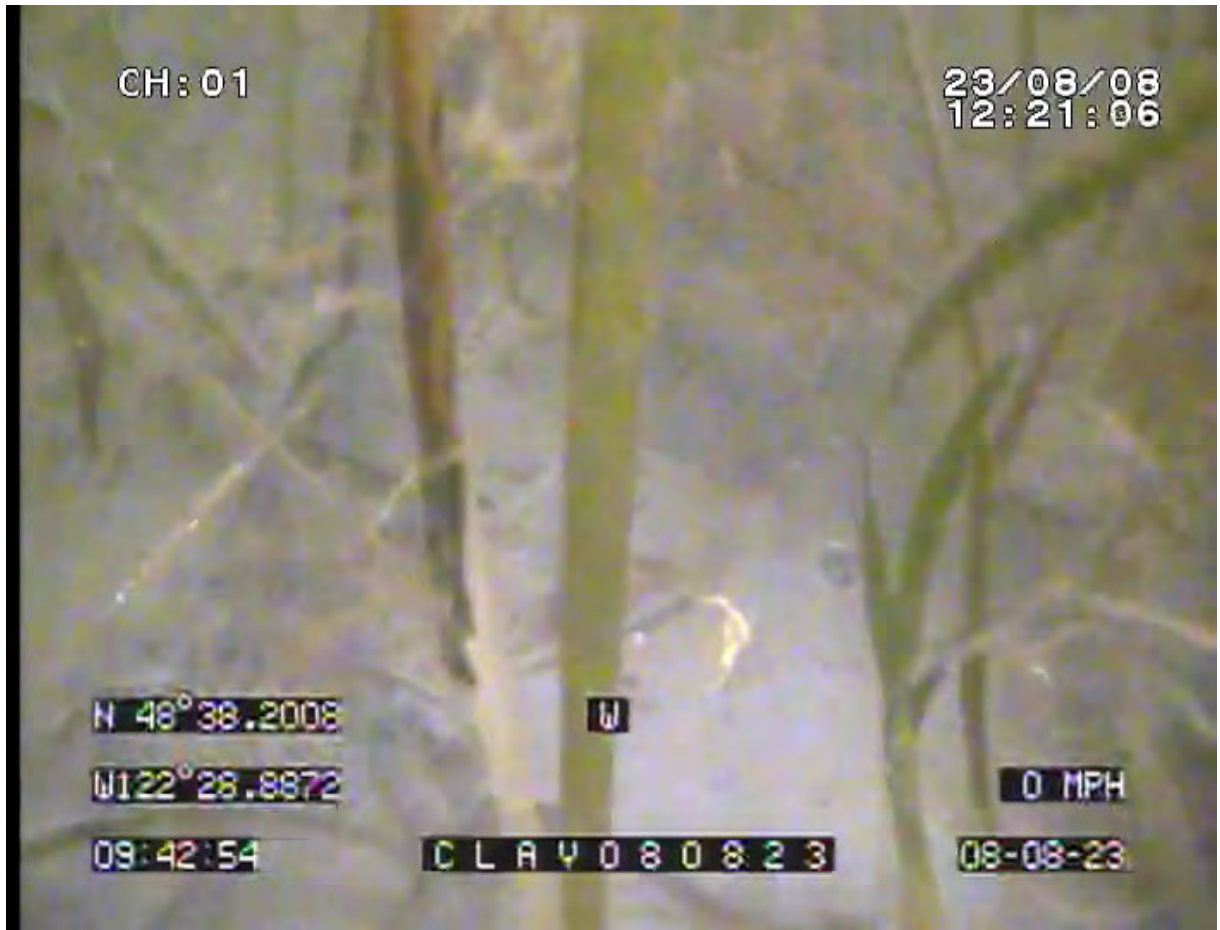
Figure 19. Dense eelgrass (*Zostera marina*) at Clayton Beach.

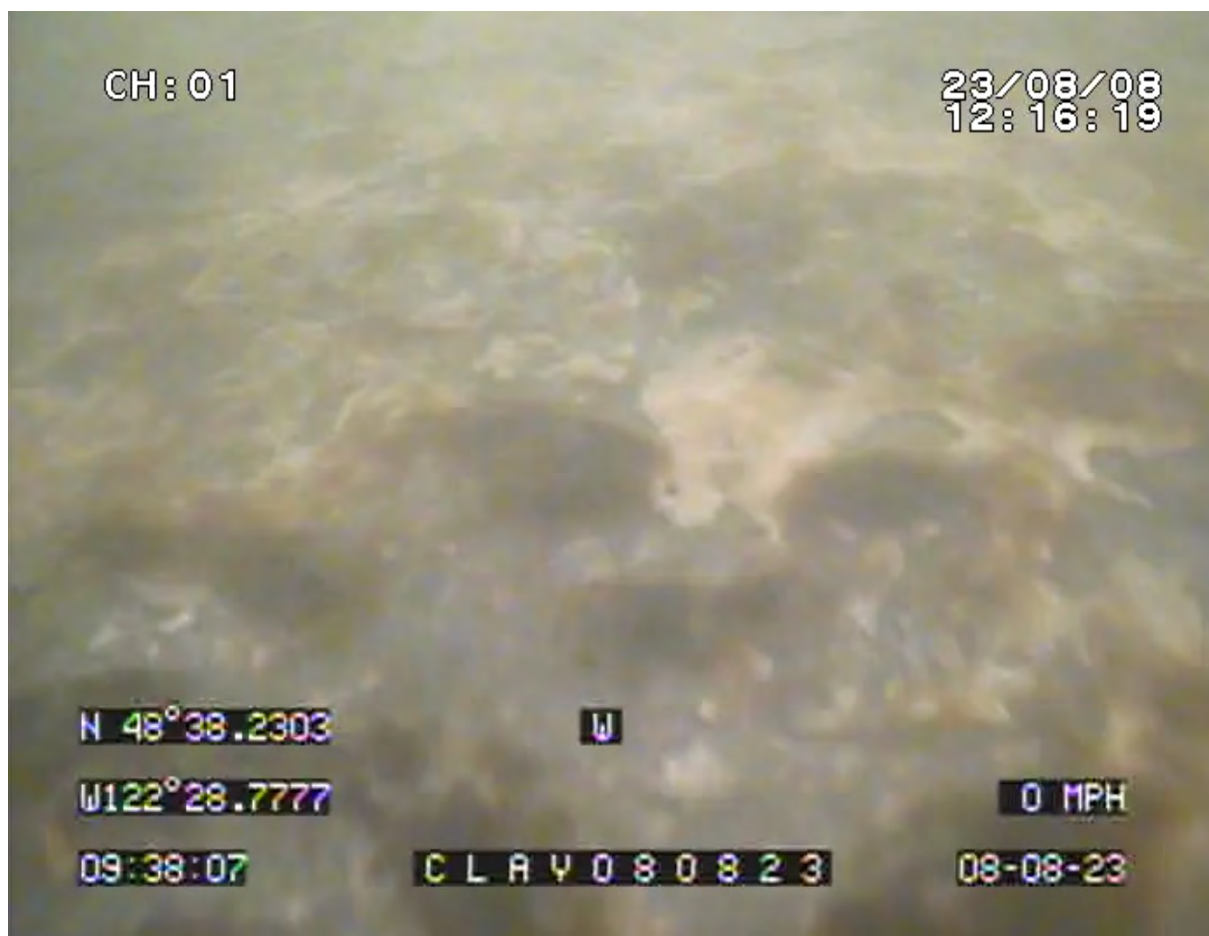
Figure 20. Video from within the Clayton Beach dredge hole, Skagit County, WA.

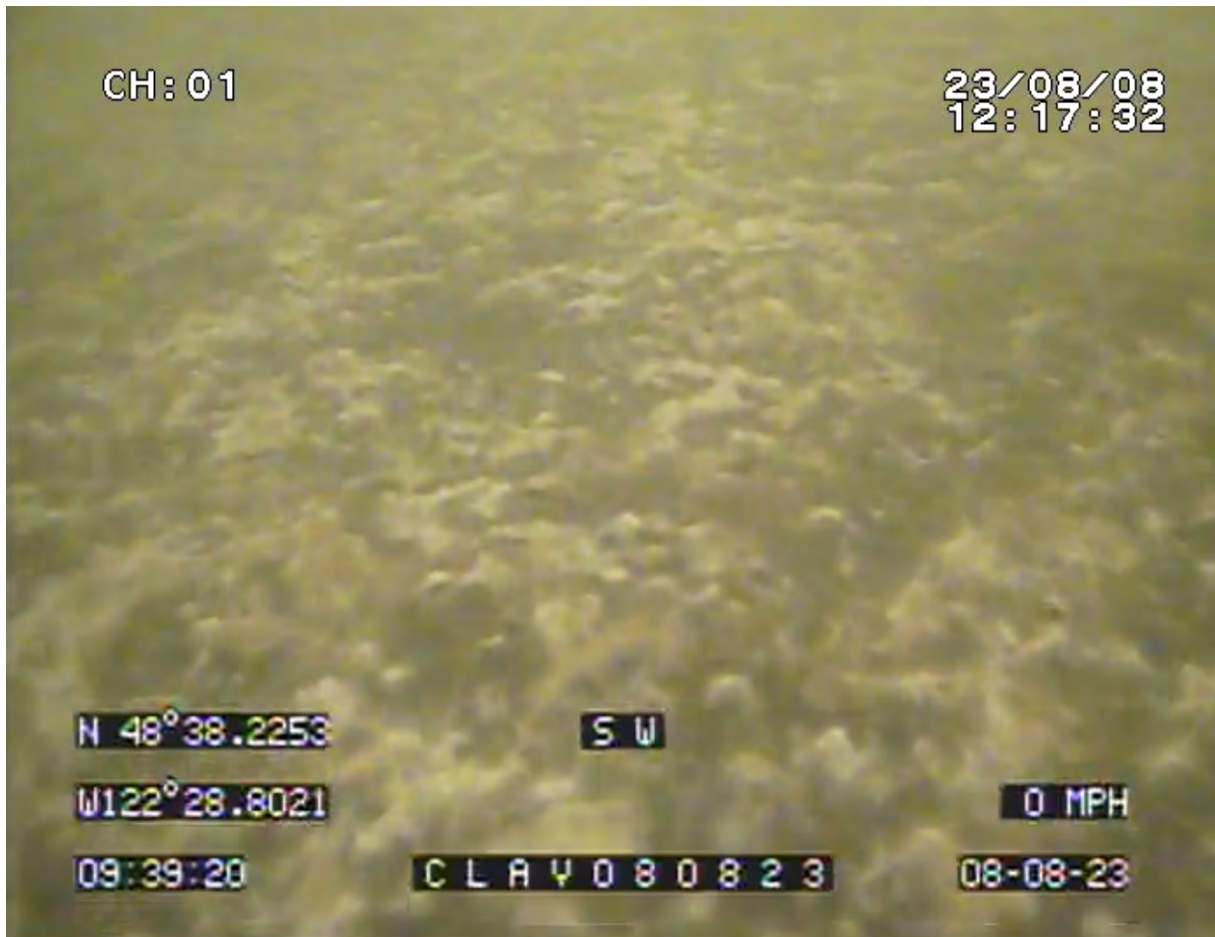
Figure 21. Video from within the Clayton Beach Divot, Skagit County, WA.
